NESHAP ASBESTOS SURVEY

Lions Park & Community Recreation Building
320 E. Wildwood Avenue
Villa Park, IL 60181-2610

Inspection Date: September 9, 2022 & October 28, 2022

MEC Project #: 22-07-376-INSP

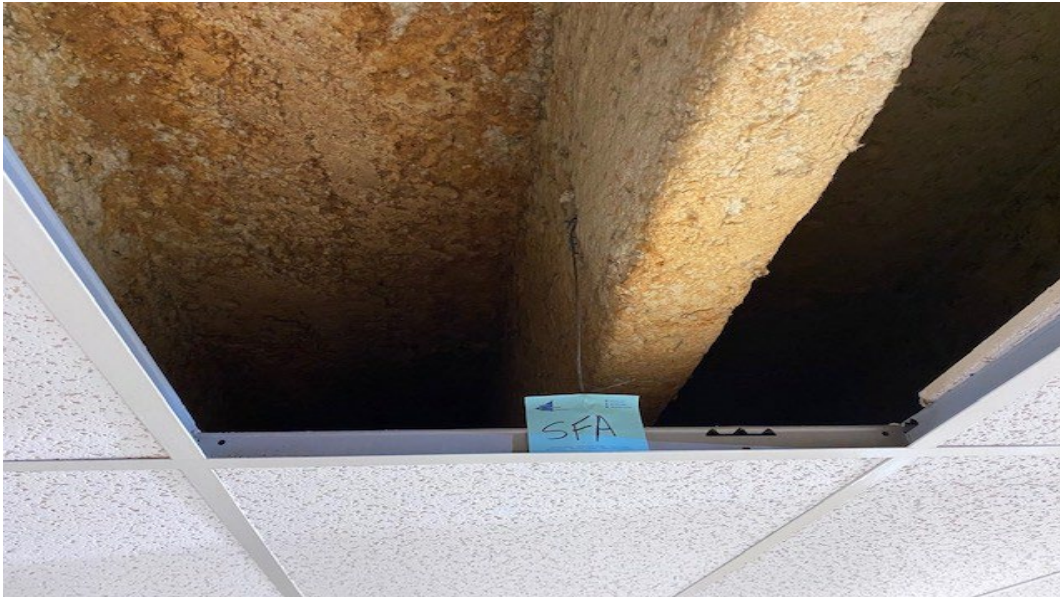
Homogeneous Area:	SFA
Material Description:	Spray-On Fireproofing
Material Location:	Community Room
ACM Y/N:	No

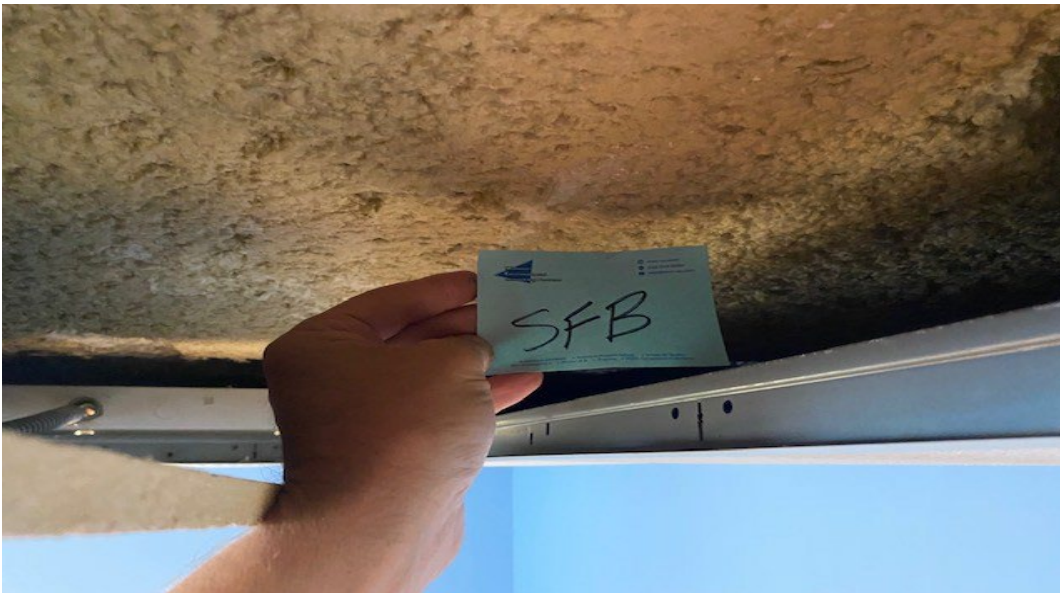
Homogeneous Area:	SFB
Material Description:	Spray-On Fireproofing
Material Location:	Offices - Lobby
ACM Y/N:	No

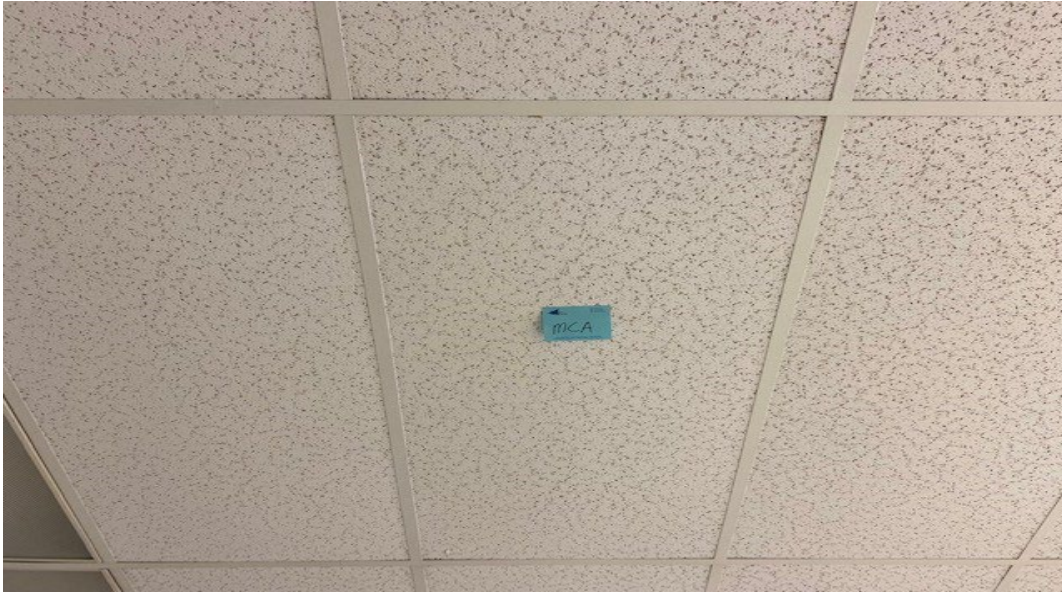
Homogeneous Area:	MCA
Material Description:	2'x4' Lay-In Ceiling Tile - Small Fissures w/Pin Holes
Material Location:	Community Room, Offices
ACM Y/N:	No

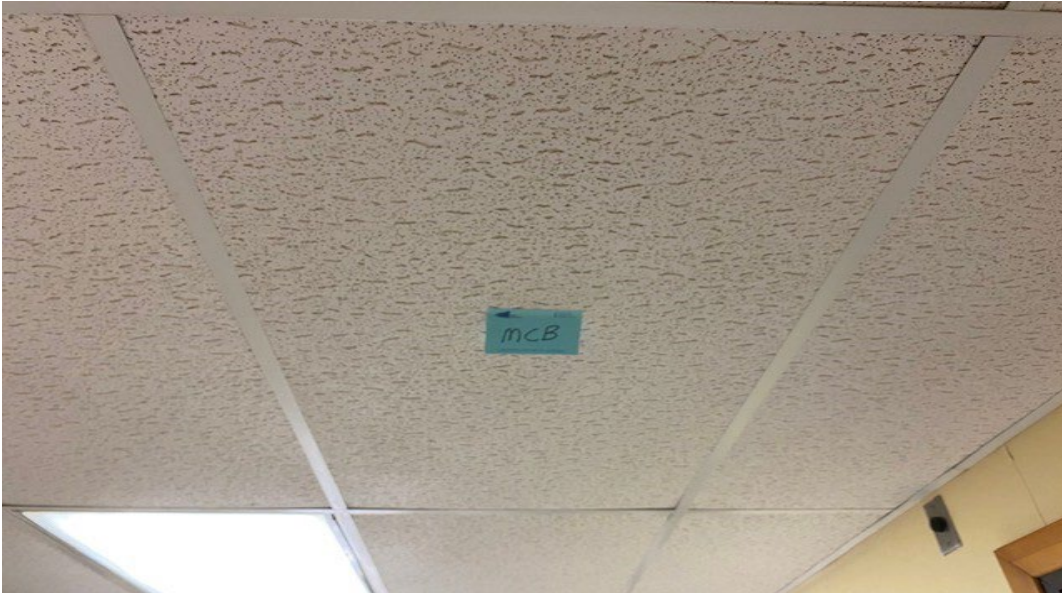
Homogeneous Area:	MCB
Material Description:	2'x2'/2'x4' Lay-In Ceiling Deep Fissures w/Pin Holes
Material Location:	Lobby, Bathrooms.
ACM Y/N:	No

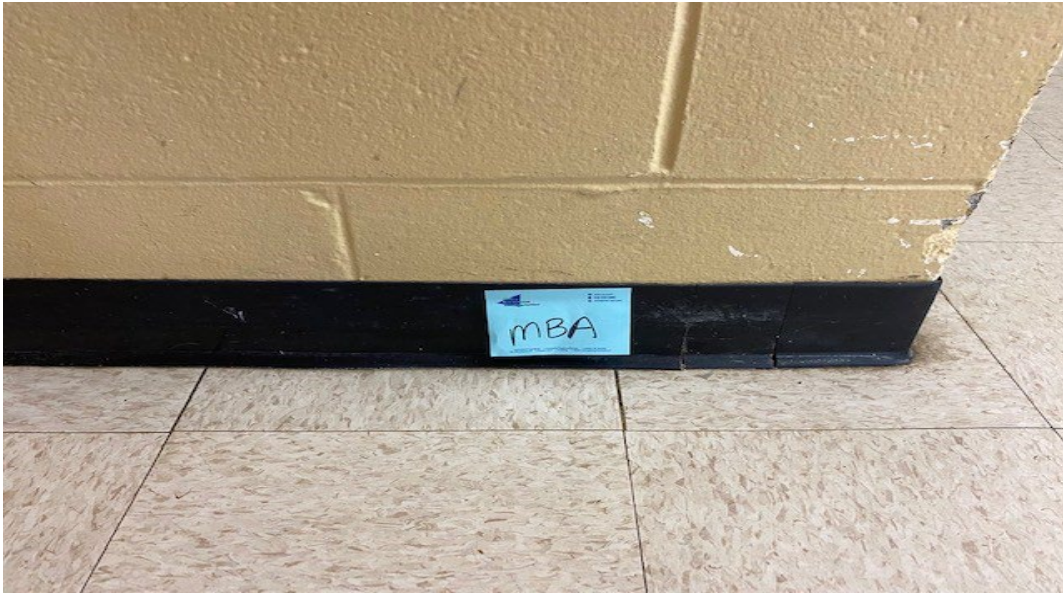
Homogeneous Area:	MBA
Material Description:	Wallbase/Mastic - Black
Material Location:	Throughout
ACM Y/N:	No

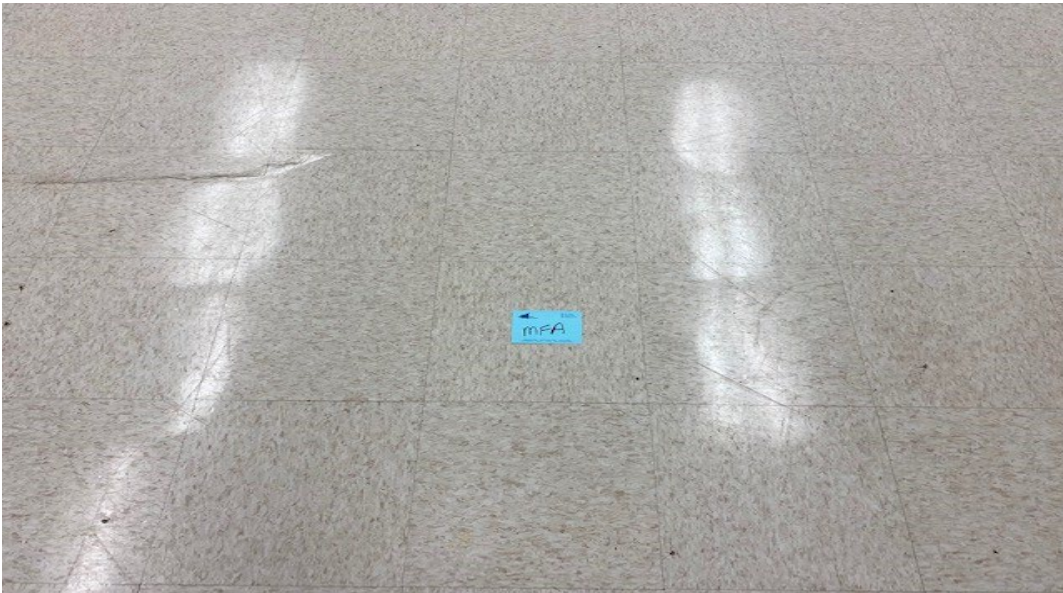
Homogeneous Area:	MFA
Material Description:	12"x12" Floor Tile/Mastic - Beige w/Gray Flecks
Material Location:	Basement - Throughout; 1st Floor- Community Room
ACM Y/N:	Yes

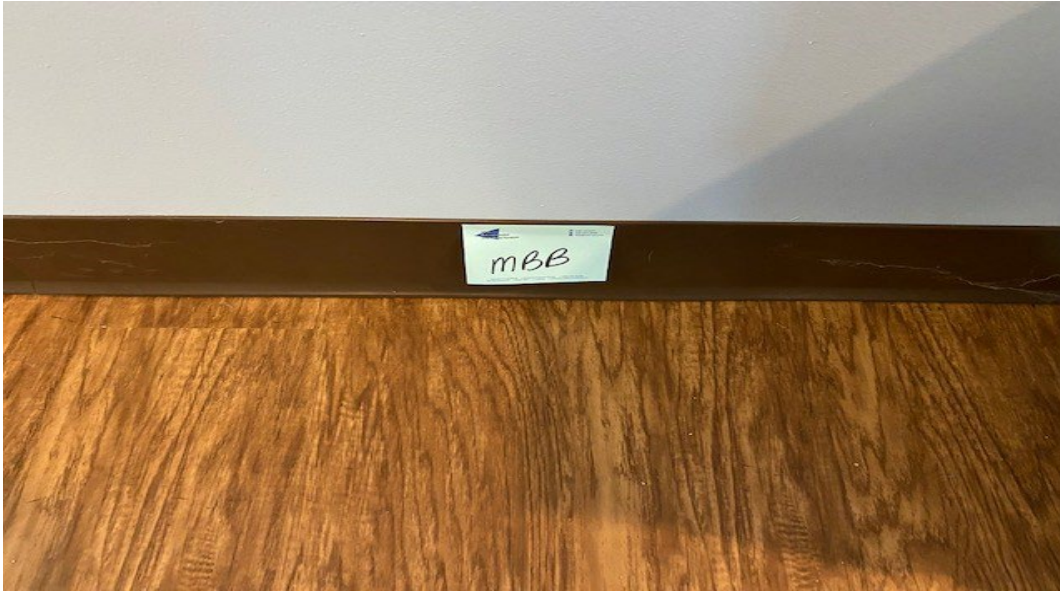
Homogeneous Area:	MBB
Material Description:	Wallbase/Mastic- Brown
Material Location:	Offices
ACM Y/N:	No

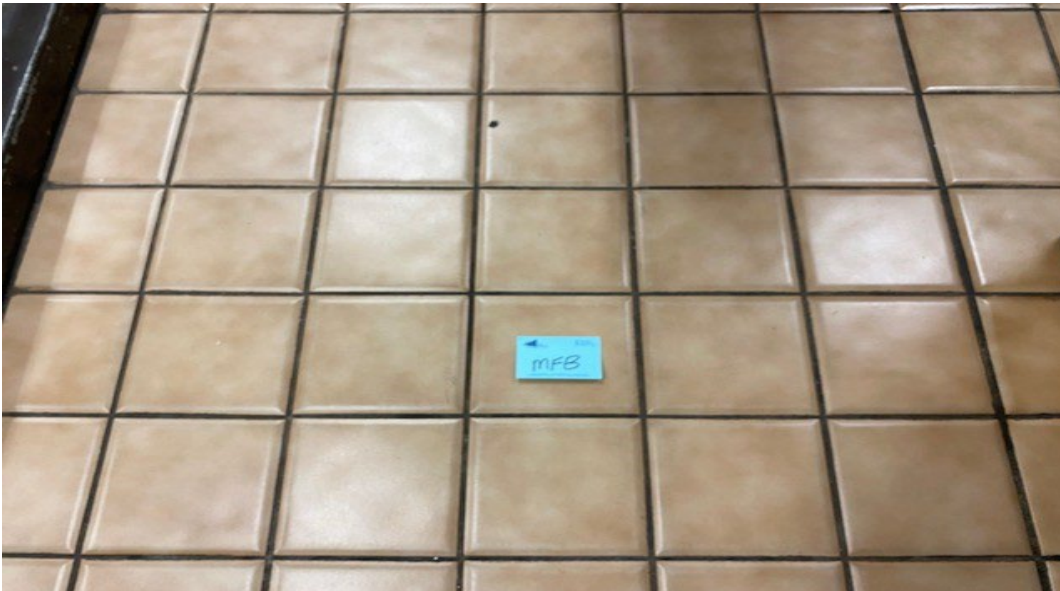
Homogeneous Area:	MFB
Material Description:	7"x7" Ceramic Floor Tile/Grout- Tan
Material Location:	Lobby, Bathrooms
ACM Y/N:	No

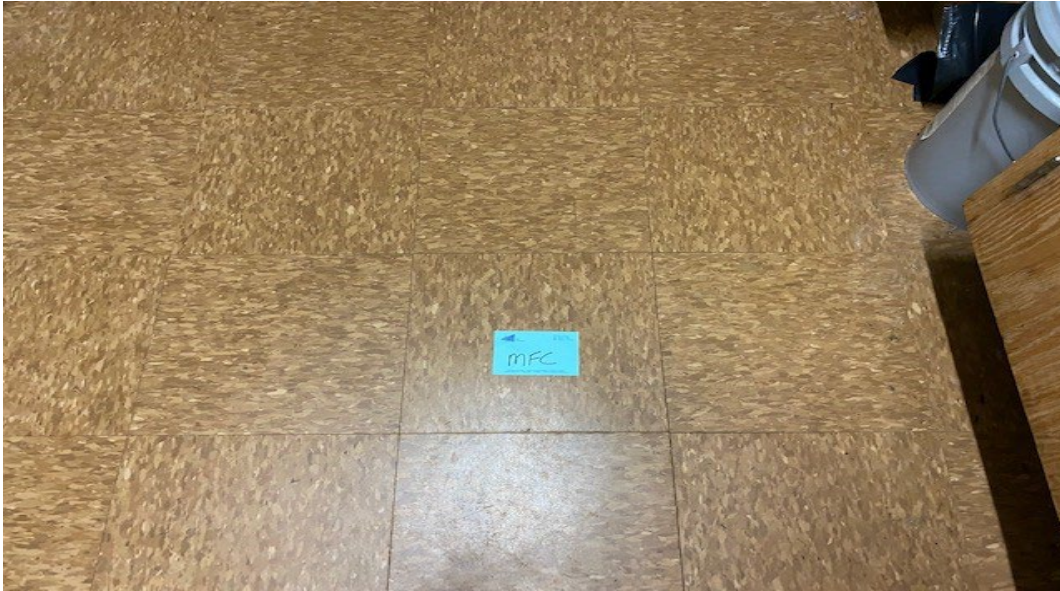
Homogeneous Area:	MFC
Material Description:	12"x12" Floor Tile/Mastic- Brown w/Tan Flecks
Material Location:	1st Floor- Storage Room
ACM Y/N:	Yes

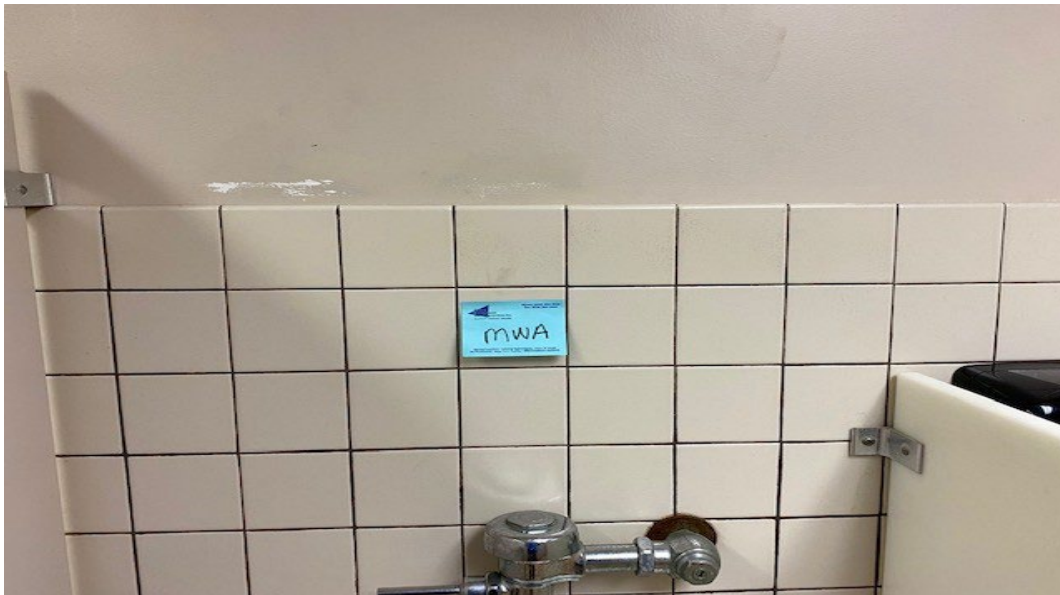
Homogeneous Area:	MWA
Material Description:	4"x4" Ceramic Wall Tile/Grout - Lt. Gray
Material Location:	1s Floor - Bathrooms
ACM Y/N:	No

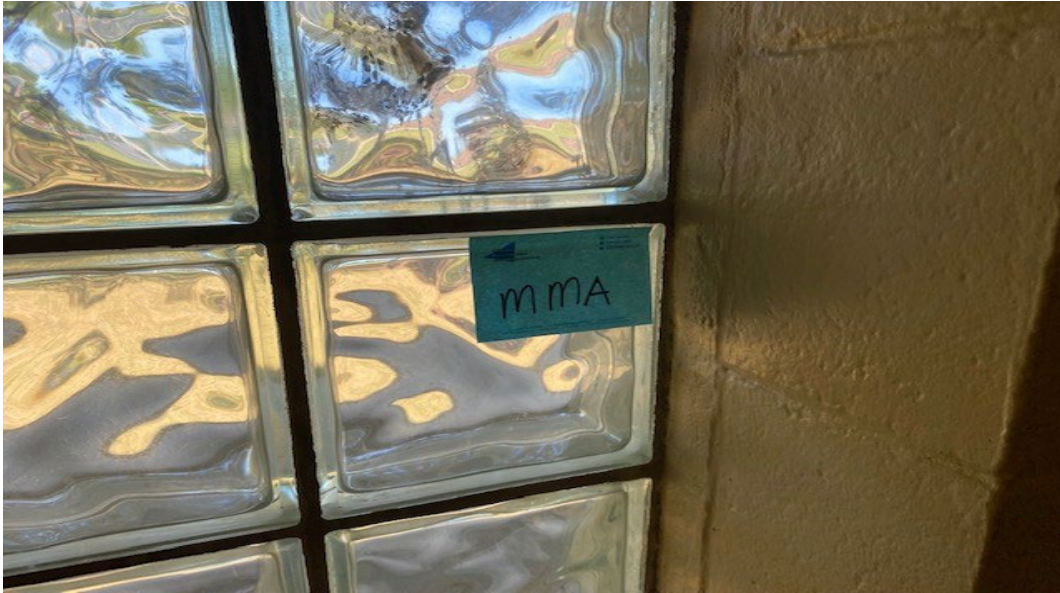
Homogeneous Area:	MMA
Material Description:	Glass Block Window Grout
Material Location:	1st Floor - Community Room
ACM Y/N:	No

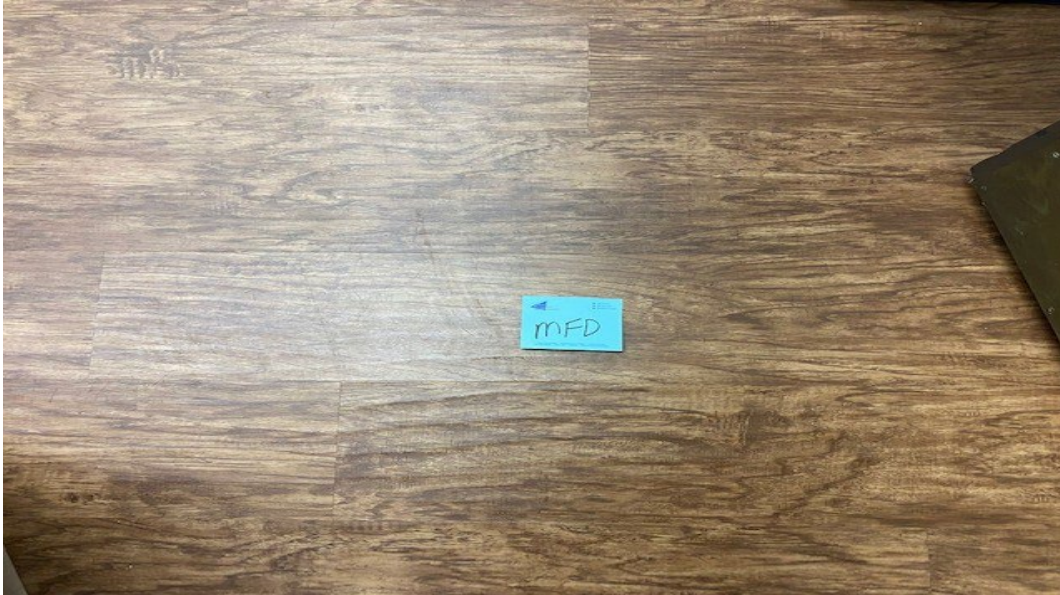
Homogeneous Area:	MFD
Material Description:	Linoleum Flooring/Mastic- Brownish
Material Location:	Offices
ACM Y/N:	Yes

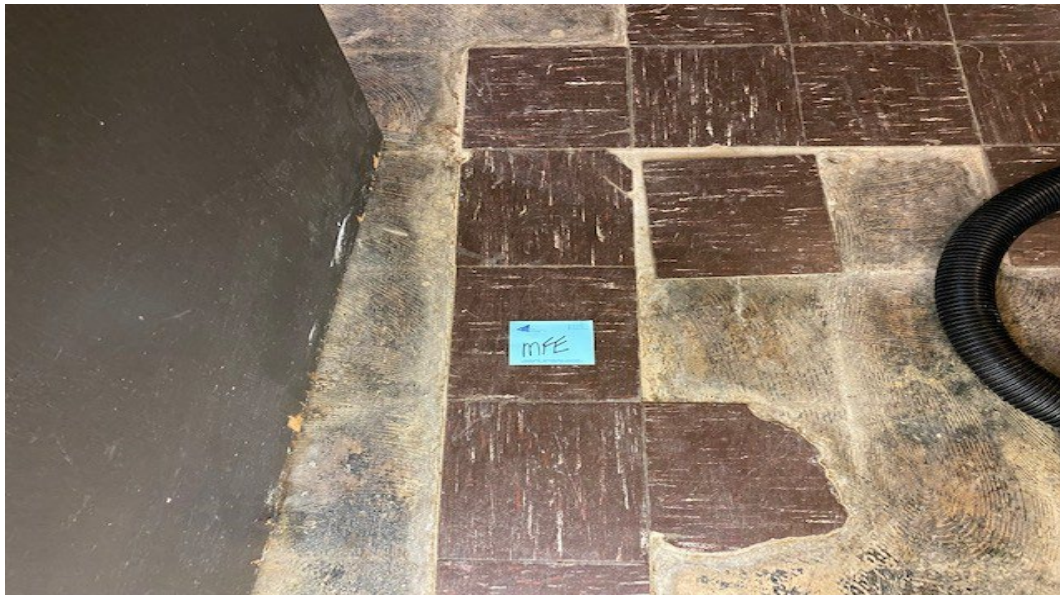
Homogeneous Area:	MFE
Material Description:	9"x9" Floor Tile/Mastic- Brown w/White Streaks
Material Location:	Basement - Storage Room, Mechanical Room
ACM Y/N:	Yes

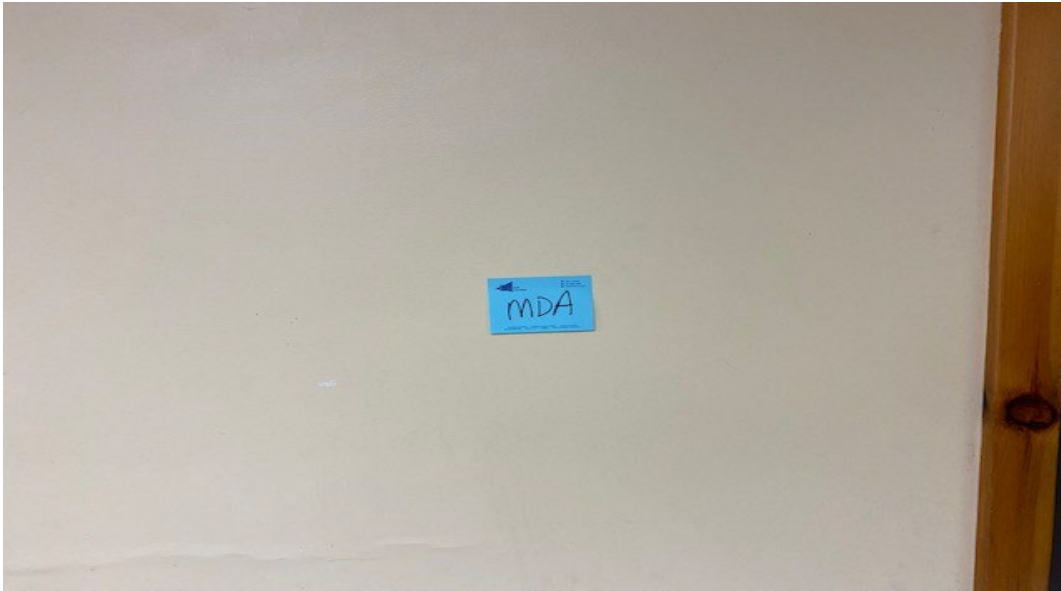
Homogeneous Area:	MDA
Material Description:	Drywall w/Compound & Tape
Material Location:	1st Floor
ACM Y/N:	No

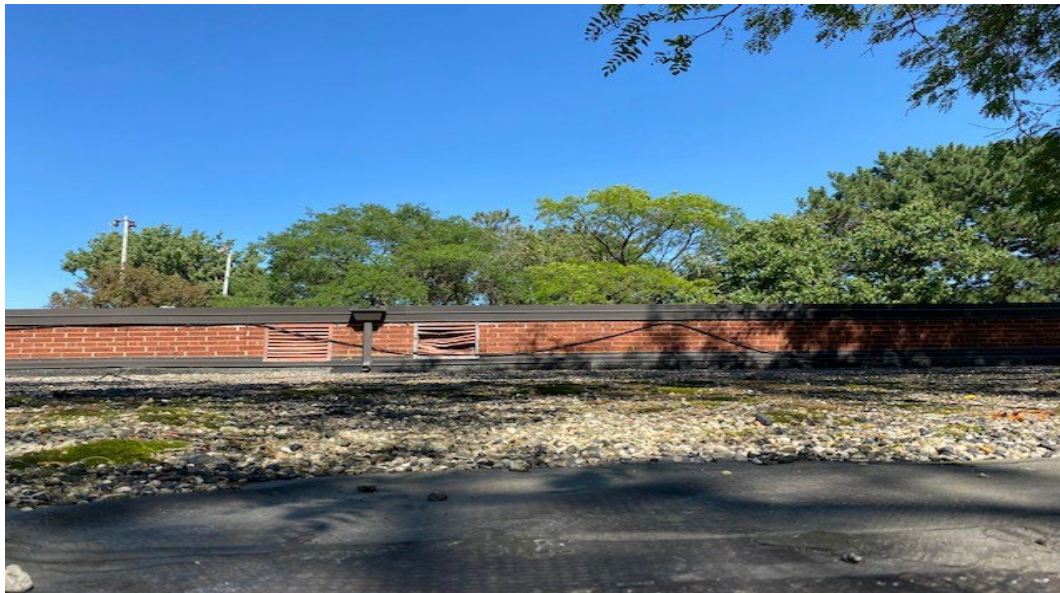
Homogeneous Area:	MRA
Material Description:	Asphalt Roofing
Material Location:	Roof
ACM Y/N:	No
