## FACILITY EVALUATION

Date: 24 September 2013

PROJECT NAME: Facility Evaluation  
Lufkin & Jefferson Pools

WA PROJECT NUMBER: 2013-010

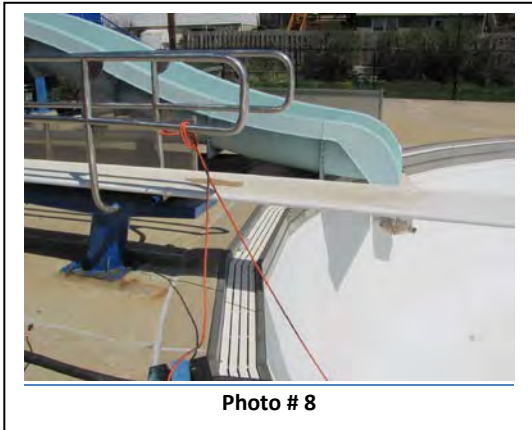
8. The hand rails on the dive stand do not extend to the pool wall. Refer to photo #8. *This is a violation of current IDPH code requirements: Section 820.200.m Diving Area – 1) Handrails shall be provided at all steps and ladders leading to diving boards, except for those ladders set at 15° or less from the vertical. Platforms and diving boards that are one meter or higher shall be protected with guard railings. One meter diving board guard rails shall be at least 30 inches above the diving board and extend to the pool water's*

*edge. All platforms or diving boards higher than one meter shall have guard rails that are at least 36 inches above the diving board or platform and extend to the pool water's edge. Three-meter platforms and boards shall have a side rail barrier.*

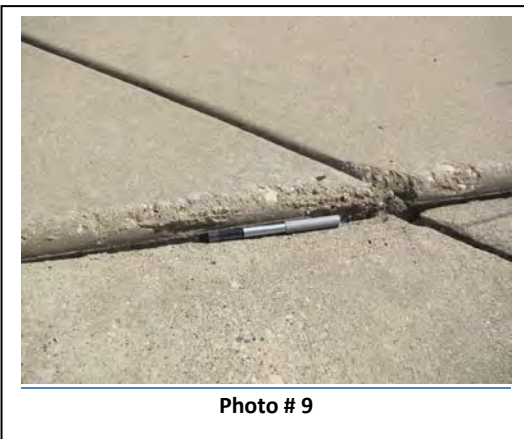
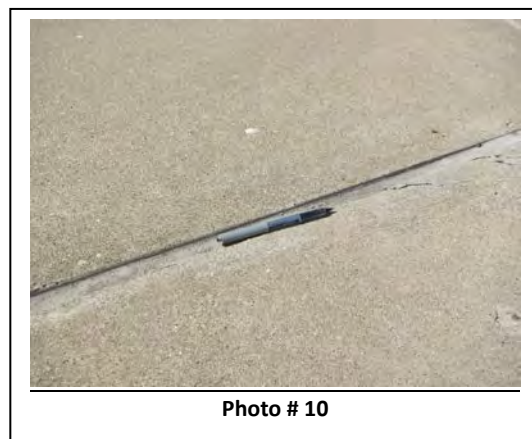
10. The decks have differential settlement which effects drainage and creates water ponding. Additionally, the settlement creates tripping/toe stubbing hazards for patrons. Refer to photos #9 and #10.

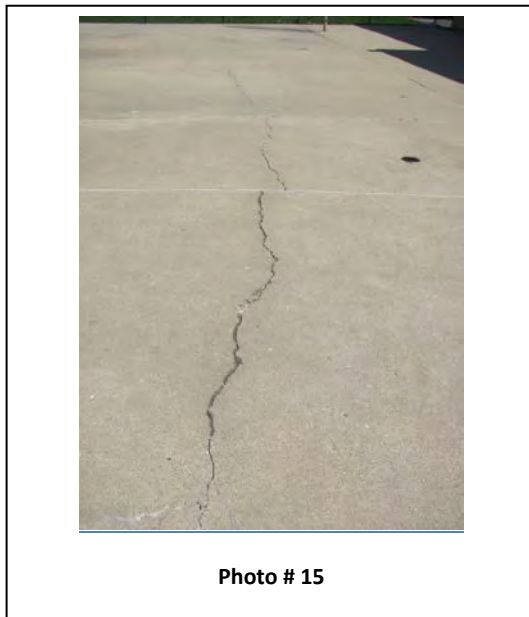
11. The decks are cracked in many areas. Refer to photo #15.

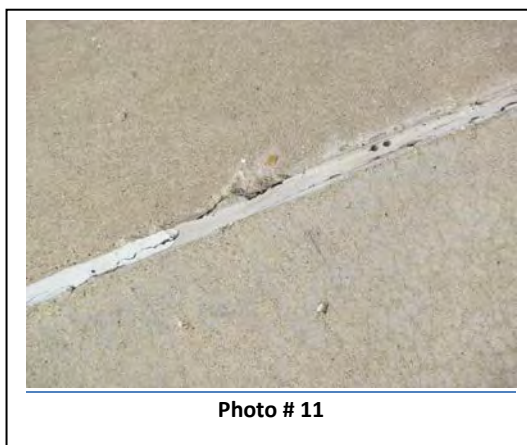
13. In many areas on the deck the caulk joints are deteriorating. Refer to photo #11.

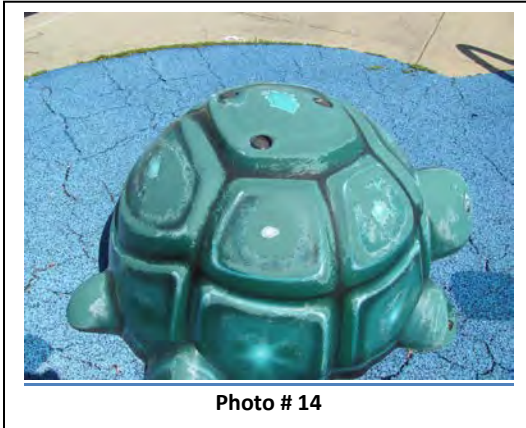
3. The Turtle spray feature is in poor condition. The finish is peeling and faded. Refer to photo #14.

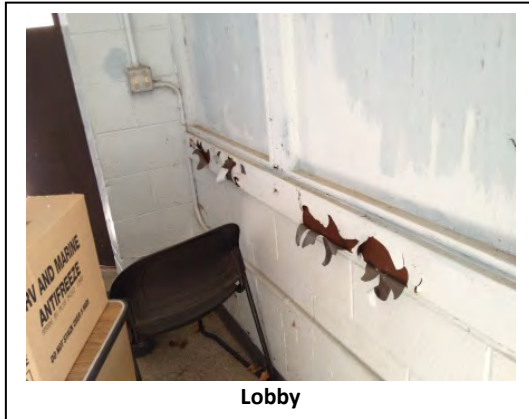
- Lobby
  - o Floors – 12 x 12 tile. Fair to poor condition.
  - o Walls – painted concrete block – peeling and flaking.
  - o Ceiling – painted plaster on underside of concrete roof plank – generally good condition

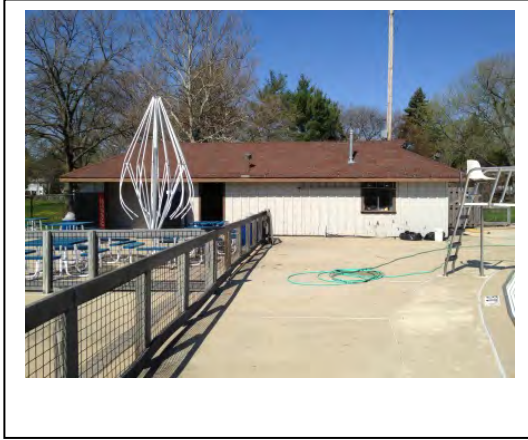
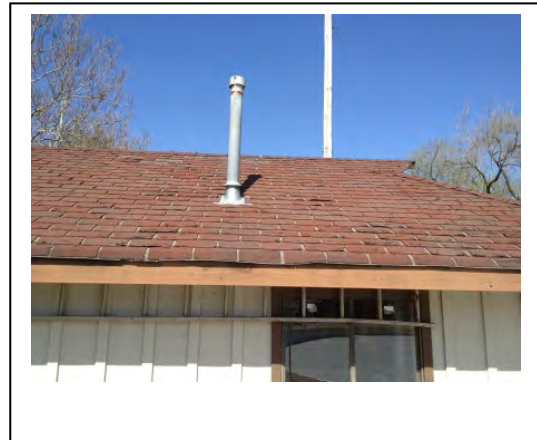
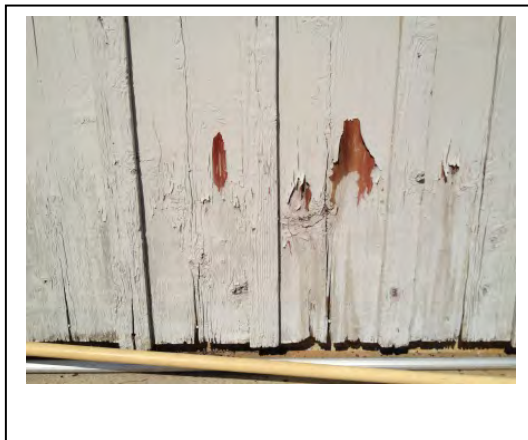
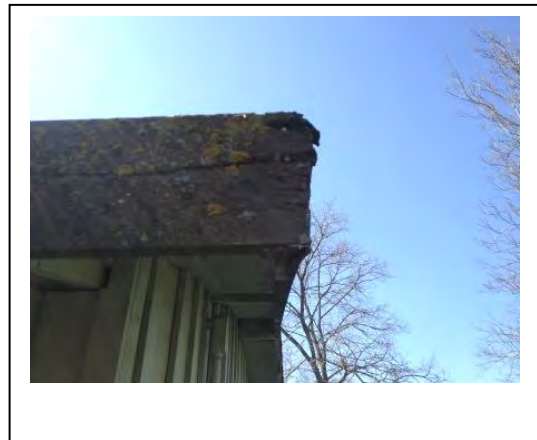
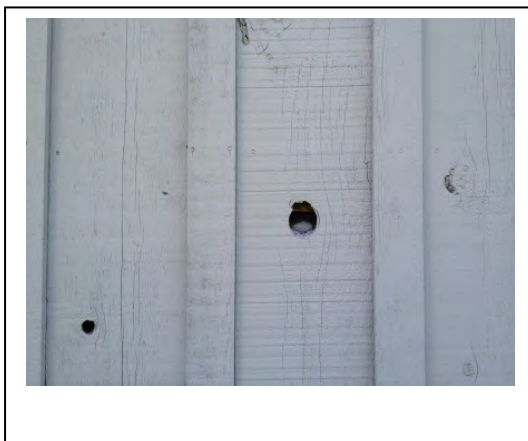
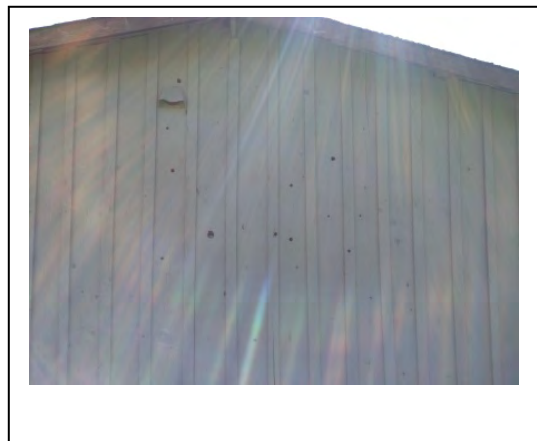
- Walls – board and batten wood – in poor condition with signs of deterioration.
- Fascia / soffits – painted wood in deteriorated condition.
- Roof – asphalt shingles – significant deterioration.

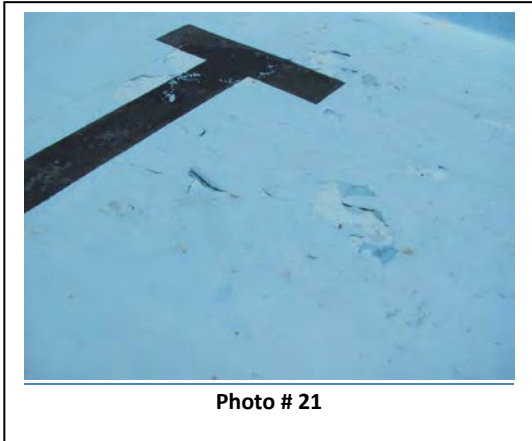
2. The painted finish on the pool is in very poor condition. Paint is peeling and cracked. Staff indicated that the pool has been repainted over the years without ever removing the old paint. Refer to photo #21.

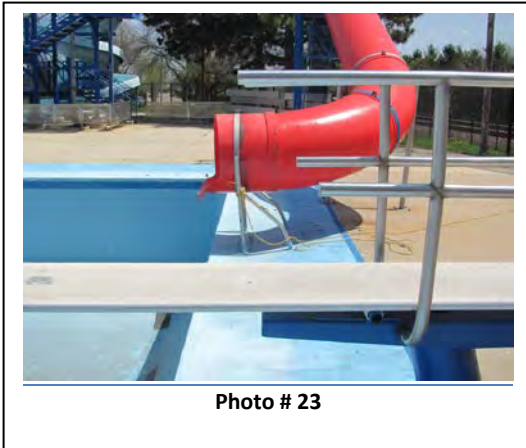
14. The hand rails on the dive stand do not extend to the pool wall. Refer to photo #23. *This is a violation of current IDPH code requirements: Section 820.200.m Diving Area – 1) Handrails shall be provided at all steps and ladders leading to diving boards, except for those ladders set at 15° or less from the vertical. Platforms and diving boards that are one meter or higher shall be protected with guard railings. One meter diving board guard rails shall be at least 30 inches above the diving board and extend to the pool water's edge. All platforms or diving boards higher than one meter shall have guard rails that are at least 36 inches above the diving board or platform and extend to the pool water's edge. Three-meter platforms and boards shall have a side rail barrier.*

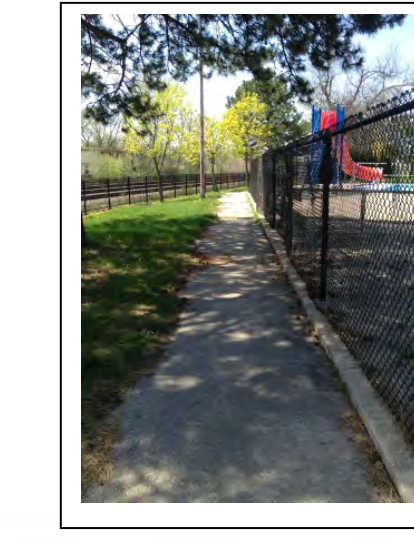
- o Perimeter walk – walk along outside of pool fence is asphalt and in poor condition exhibiting settling, weed growth and overall deterioration.

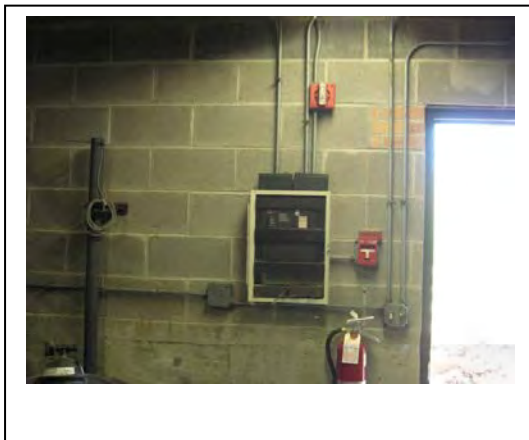
- o Interior lighting fixtures are in average to poor condition. Lighting levels seemed adequate,
- o Receptacles range from average to good condition. Although, the receptacle layout in the building meets the minimum code requirement, extensive use of extension cords was noticed.
- o Exit sign in average condition.
- o The electrical panels are in good condition.
- o The capacity of the electrical services in both buildings is adequate.
- o Exterior lighting is in average condition but does not meet dark sky friendly code requirements in the Bathhouse/Filter building.
- o No fire alarm system in the Bathhouse/Filter building.
- o The enclosures of few electrical disconnects are corroded
