## FACILITY EVALUATION

Date: 24 September 2013

PROJECT NAME: Facility Evaluation  
Lufkin & Jefferson Pools

WA PROJECT NUMBER: 2013-010

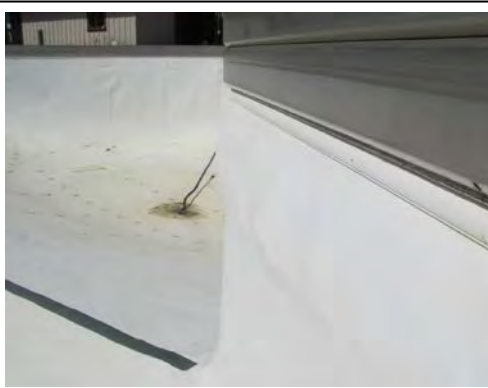
**Photo # 1**

1. The pool structure under the PVC pool liner has significant deterioration. High ridges protrude out and can be felt and seen in many areas. This condition is occurring on both the floor and walls of the pool structure. In some areas sharp edges can be felt. The deteriorating walls behind the liner protrude up to 2" out in some areas, indicating severe deterioration. Refer to photos #1, #2 and #3.

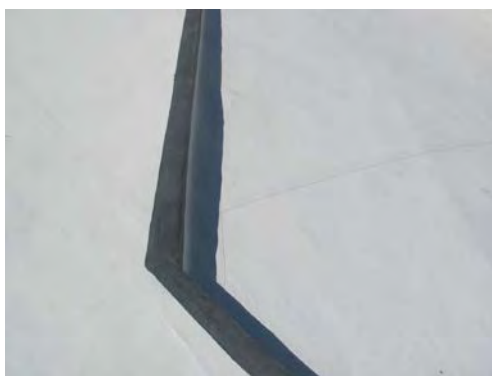
Photo # 4

3. Anchors have been installed in the deep end of the pool to hold the liner down when ground water seeps in underneath.
4. At the transition to the deep portion of the pool there is a 12" vertical step down. Refer to photo #4. *This is a violation of current IDPH code requirements: Section 820.200.f Slope of Pool Floor - The floor of a pool shall slope downward toward the main drain. The slope in shallow areas shall not exceed one foot vertical in 12 feet horizontal except for a slope directed downward from a transition point, which shall not exceed one foot vertical in 3 feet horizontal. In portions of the pool with a depth greater than 5 feet, the front slope of the deep area shall not be steeper than one foot in 3 feet.*

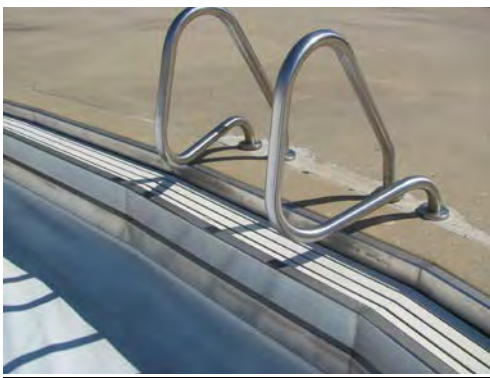
Photo # 5

5. The grab rail at the shallow end of the pool does not incorporate a recessed step. The rise to get out of the pool is approximately 18", which could make it very difficult to use for many patrons. Refer to photo #5.

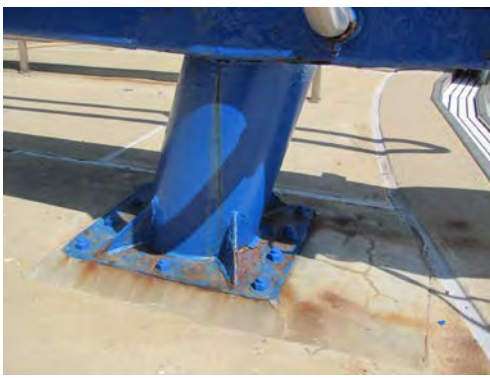
Photo # 6

6. The safety line in the pool, at the transition to the deep end, is not set back 12" from the transition point. *This is a violation of current IDPH code requirements: Section 820.200.g Transition Point - Transition points shall be marked with a stripe on the pool floor having a width of at least 4 inches and a color that contrasts with that of the floor, and with a buoyed safety rope with colored buoys, installed at least one foot on the shallow side of the transition point. In other pools having adjoining shallow and deep areas, a safety rope with colored buoys shall be installed where the water depth reaches 5 feet.*
7. The dive stand is in poor condition, having significant deterioration. Refer to photo #6 and #7.

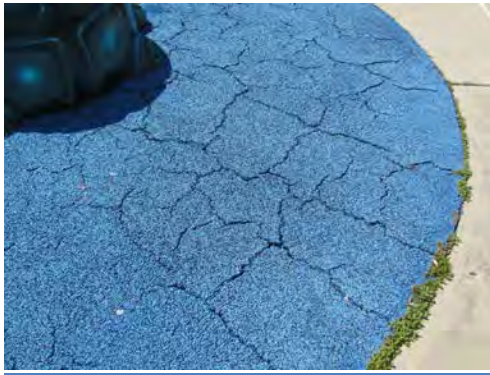
Photo # 12

1. The safety surface is severely deteriorated. Weeds are growing in the safety surface. Refer to photos #12 and #13. *This is a violation of current IDPH code requirements: Section 820.240 Spray Pools – a) Material. Spray pools shall be constructed of impervious material that has a slip-resistant finish.*

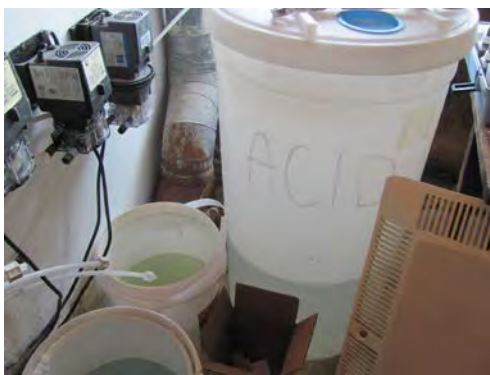
Photo # 16

3. The filtration piping is a mix of schedule 40 and schedule 80 PVC piping.
4. Muriatic Acid is stored in the mechanical room, allowing off-gassing and producing a corrosive atmosphere.

5. There is no containment for the muriatic acid, which creates a hazardous situation if a leak or a spill occurred. Refer to photo #16.

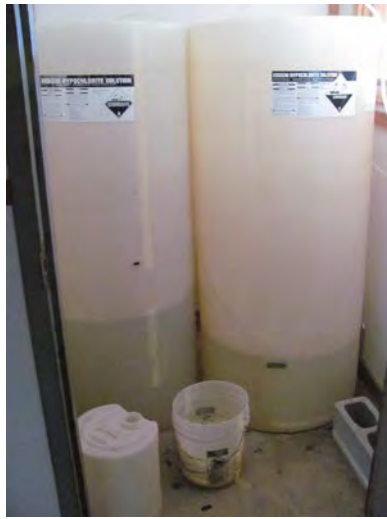
Photo # 17

6. Sodium hypochlorite is used as a disinfectant. There is no containment for the chlorine, which creates a hazardous situation if a leak or a spill occurred. Refer to photo #17.

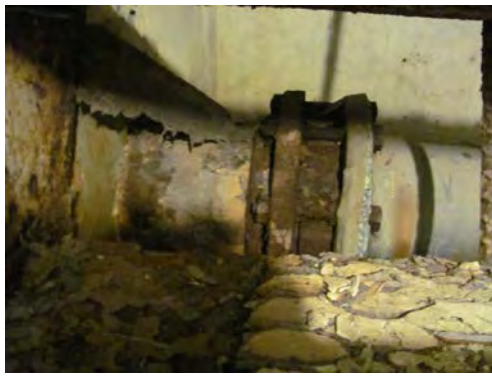
Photo # 18

8. The original existing main drain piping coming into the mechanical room is severely corroded. Refer to photo #18. The condition of the underground piping that cannot be viewed is most likely the same.

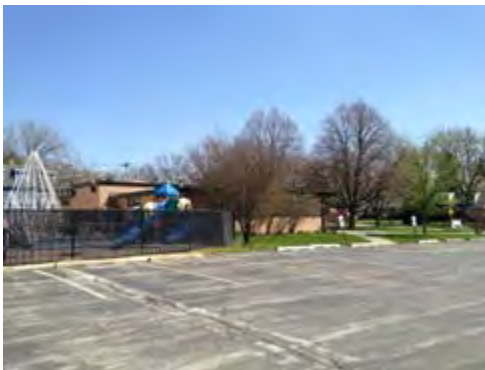
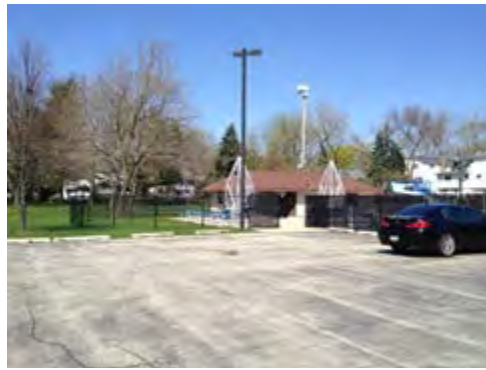
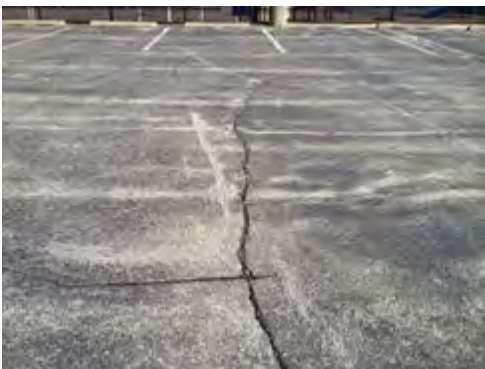
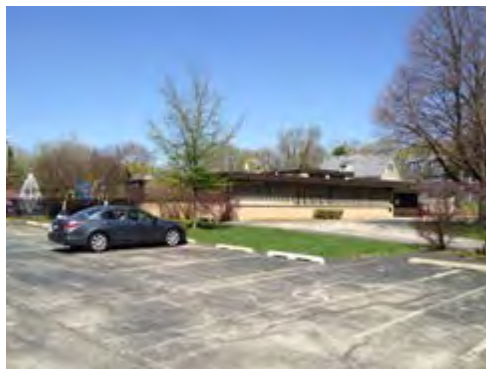
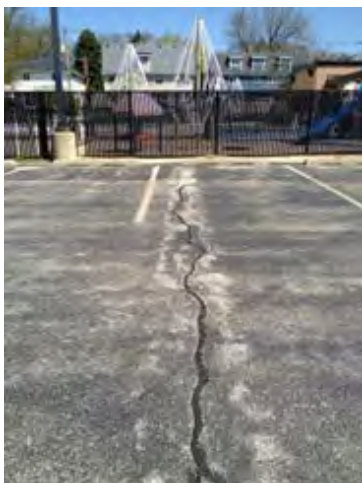
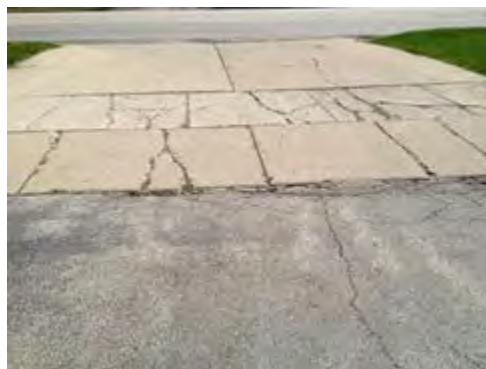
- Parking Lot
  - o The Parking lot and drives are asphalt. The lot is in fair condition.
  - o The lot and drives require some crack repair and should be sealcoated and restriped in the near future.
  - o We noted several deteriorated and missing wheel stops.
  - o The concrete apron in the R.O.W. exhibited significant cracking and should be replaced.

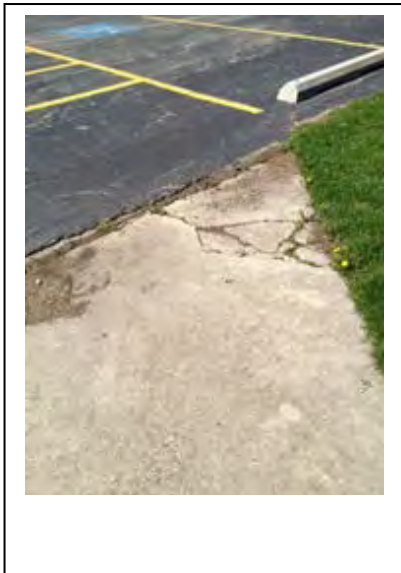
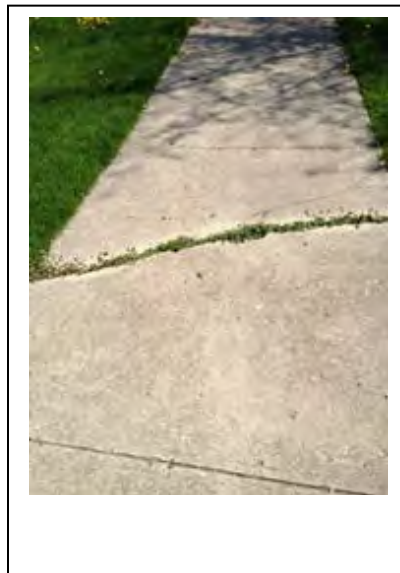
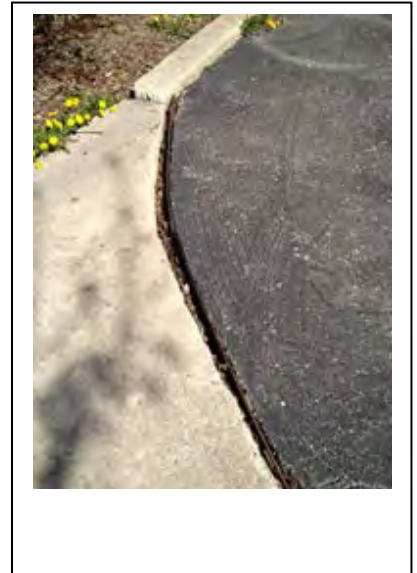
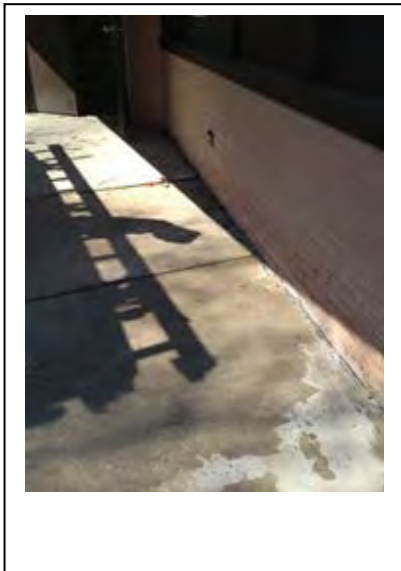
- Concrete Walks
  - o Several concrete walks are in poor condition and require replacement.

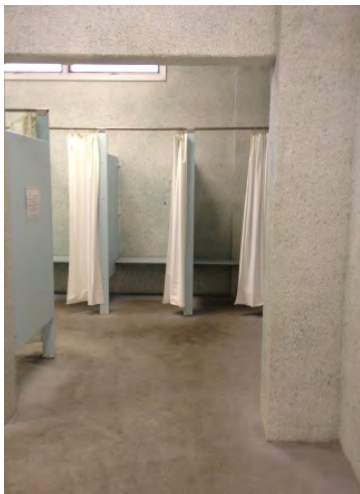
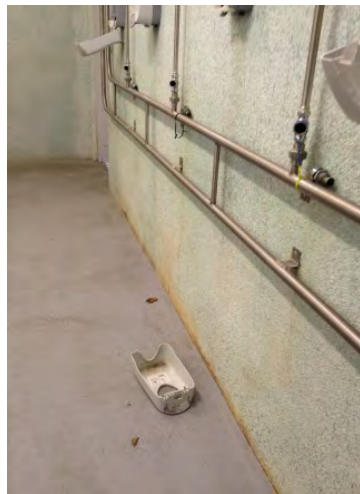
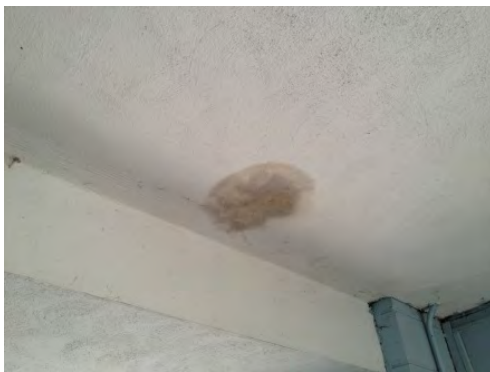
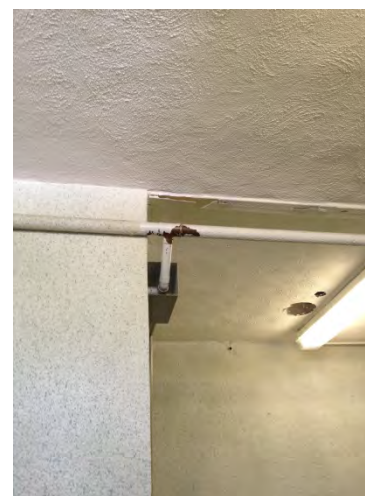
- Women's Locker Room
  - o Floors – epoxy – fair condition.
  - o Walls – painted plaster – generally good condition with some staining.
  - o Ceiling – painted plaster on underside of concrete roof planks – generally good condition with some minor flaking. One area shows water damage.
  - o Benches – solid plastic on metal pedestals – good condition.
  - o Toilet Partitions – solid plastic in good condition.

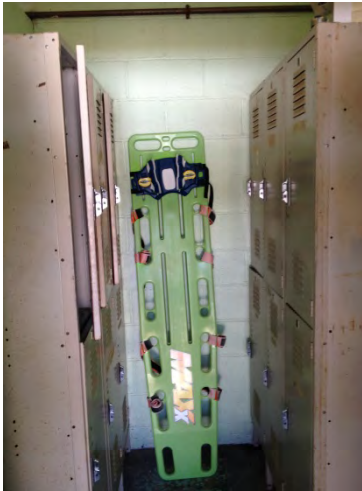
- Guard Office
  - o Floor – 12 x 12 tile – fair condition.
  - o Walls – painted block – fair condition.
  - o Ceiling – exposed concrete roof plank.

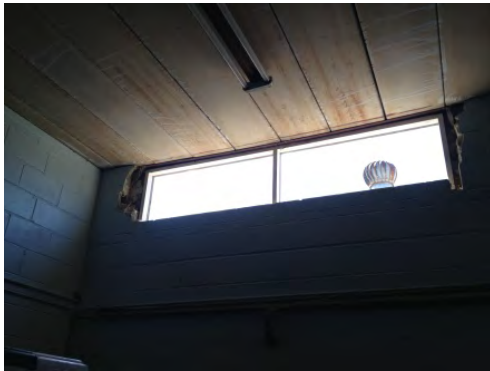
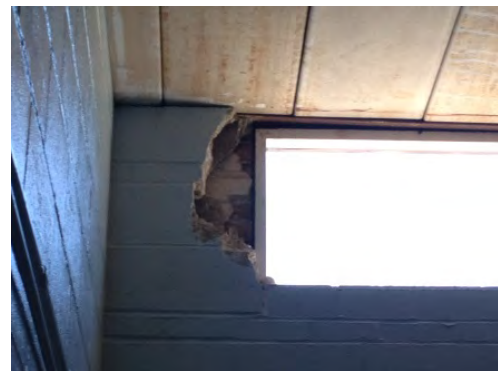
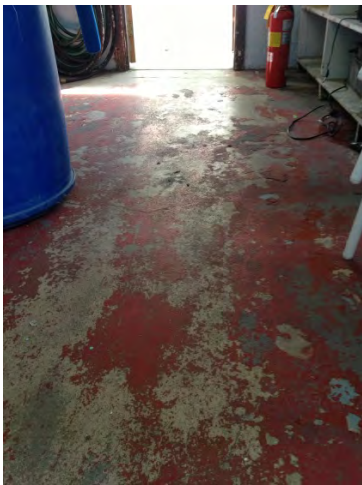
- Staff Storage Room
  - o Floor – painted concrete – poor condition.
  - o Walls – painted concrete block – fair condition.
  - o Noted deterioration above south facing windows where support of roof planks is failing and roof plank is partially bearing on top of window frame. We recommend immediate temporary support to avoid further deterioration / collapse until a permanent solution is found.
  - o Ceiling – exposed concrete roof planks in generally good condition.

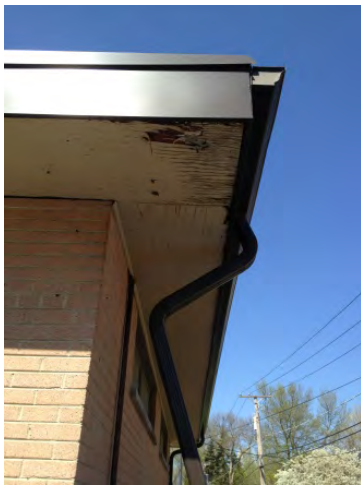
**Soffit / Downspout at NE  
Corner**

- Bathhouse Exterior
  - o Walls –
    - Face brick – signs of deterioration along base of wall – overall in fair condition.
    - West wall at south corner has bulging / shifting face brick – should be repaired in the near future.
  - o Wood slats – east wall at Lobby – overall in poor condition with peeling and flaking paint and some dry rot.
  - o Soffits – painted wood in fair condition. Some peeling, flaking and deterioration.
  - o Fascia – prefinished aluminum in good condition.
  - o Windows – prefinished aluminum in good condition. Exception is window pnm west wall at guard office. This is a wood window and is in poor condition.
  - o Stone sills at windows in good condition.
  - o Downspouts – prefinished aluminum in fair condition – missing downspout at southwest corner.

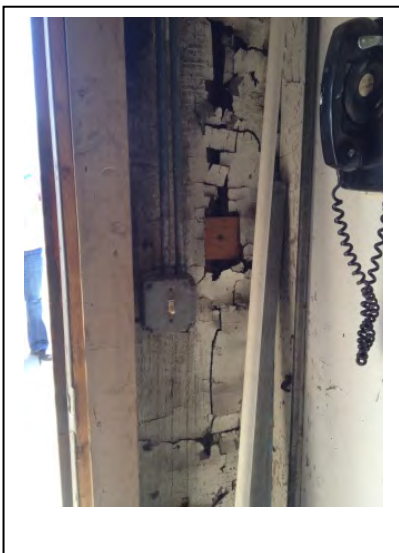
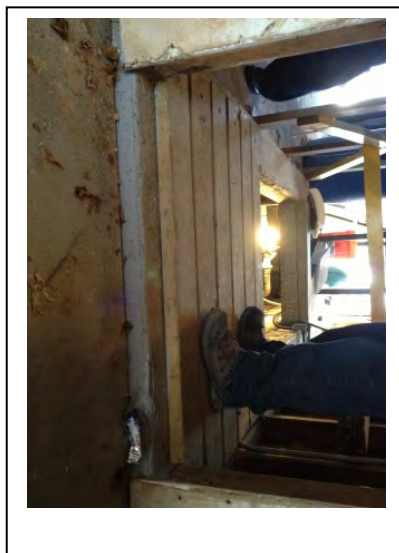
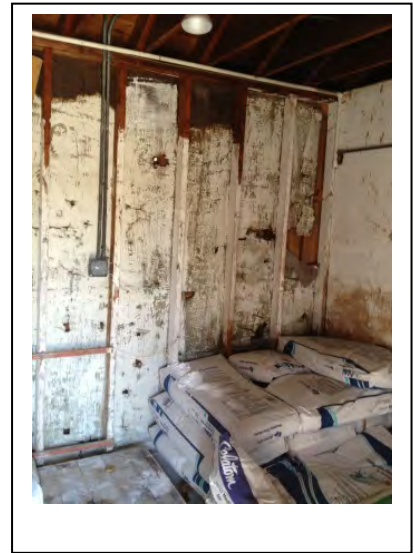
- Filter / Concessions Building – Building is at rear (west) side of site and is approximately 860 GSF.
  - o Interior
    - Floor – exposed concrete
    - Walls - exposed construction – wood studs with partial drywall. Overall poor condition.
    - Concessions currently not operational.
    - Overall poor condition.
    - OSHA – confined space at filtration pit.

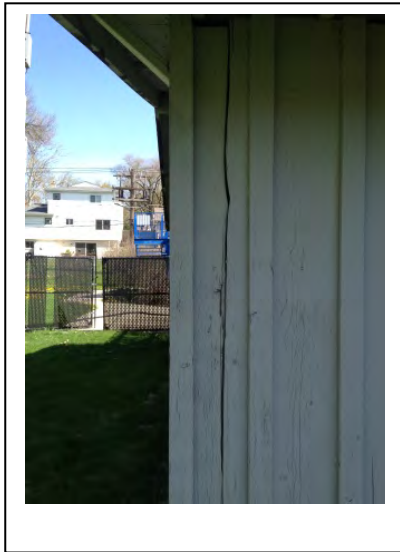
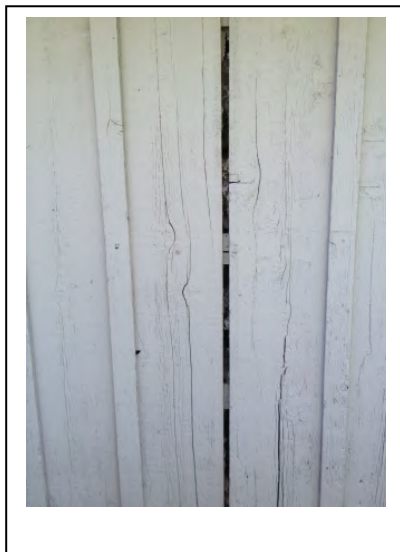
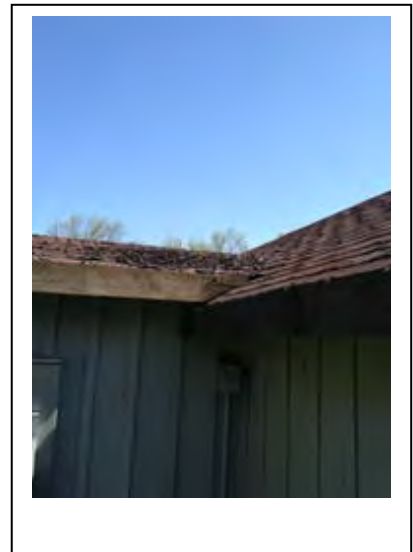
- Walls – board and batten wood – in poor condition with signs of deterioration.
- Fascia / soffits – painted wood in deteriorated condition.
- Roof – asphalt shingles – significant deterioration.

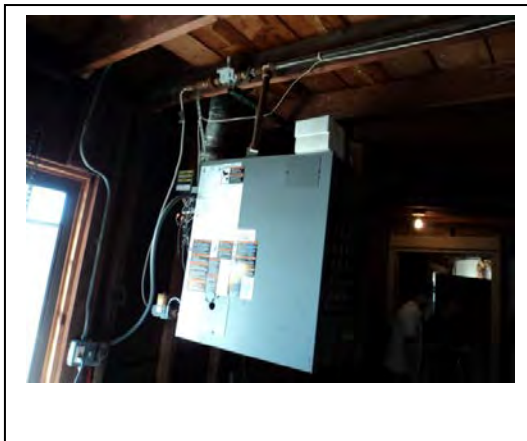
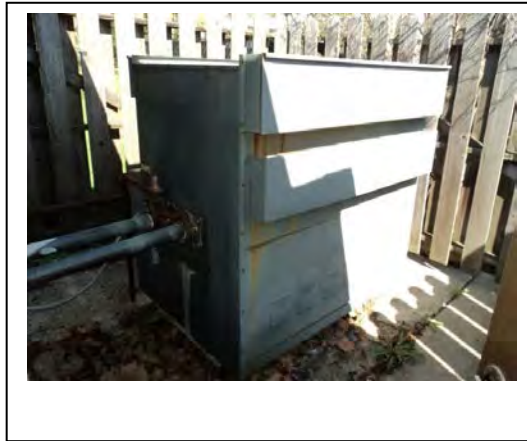
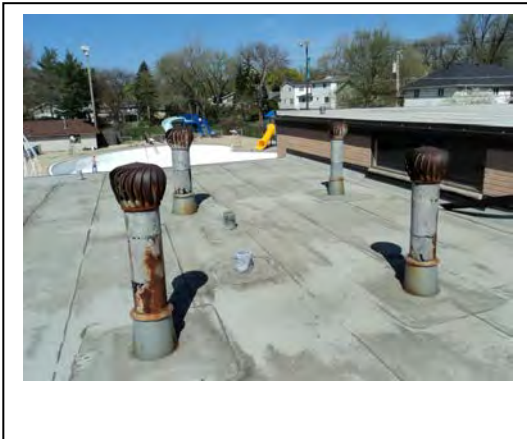
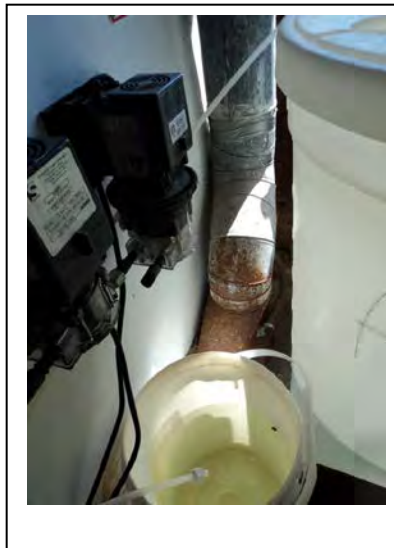
- Filter Building
  - o Gas fired unit heater in pool equipment room in good condition.
  - o Galvanized exhaust duct in chemical storage room badly corroded.
  - o Associated duct to gable louver in poor condition with sagging flexible ductwork.
  - o Pool heater mounted at grade in fair to poor condition.
  - o Opening in roof exposed to weather, appears to be from removed roof mounted equipment.
- Bathhouse
  - o Ceiling grates are in poor condition
  - o Associated draft inducer vents on roof are badly corroded.

- Filter Building
  - o Improper combustion air openings for unit heater.
- Bathhouse
  - o No code violations observed.

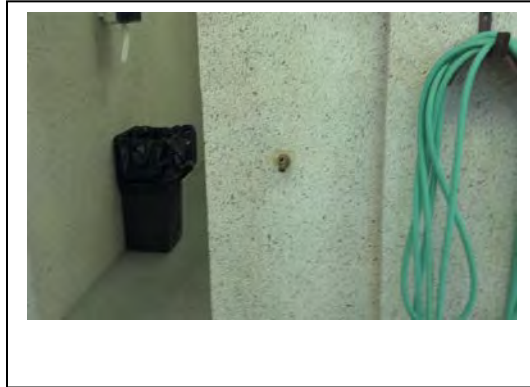
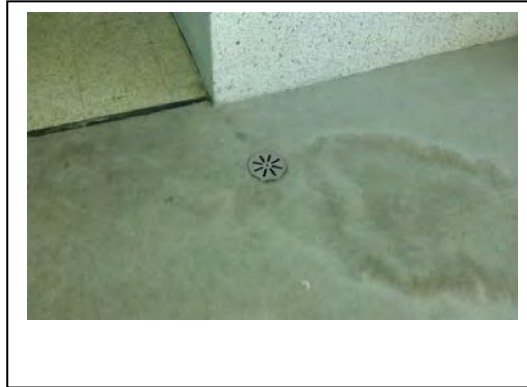
- Bathhouse
  - o Men's Locker Room consists of one (1) hose bibb and three floor drains.

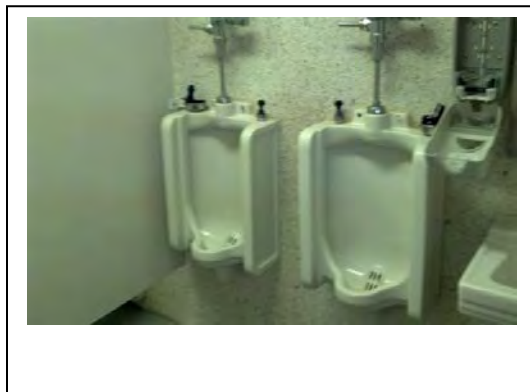
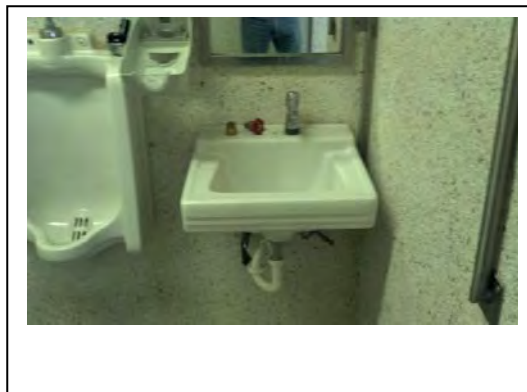
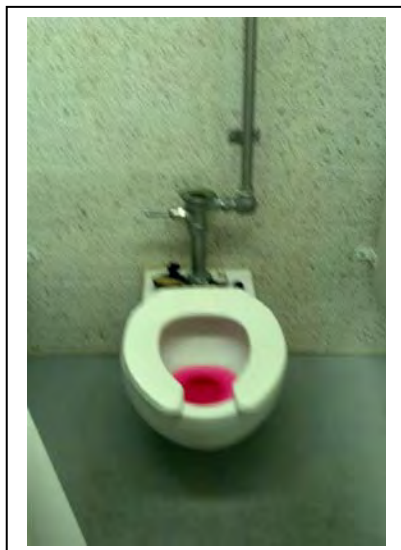
- o Men's Dry Toilet Room consists of one (1) wall hung china lavatory with metering faucet, two (2) urinals with manual flush valves, two (2) wall hung water closets with manual flush valves and one (1) floor drain.

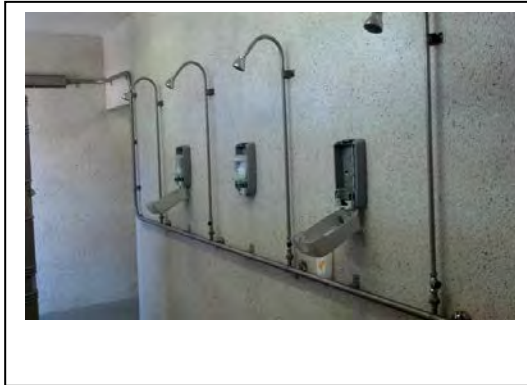
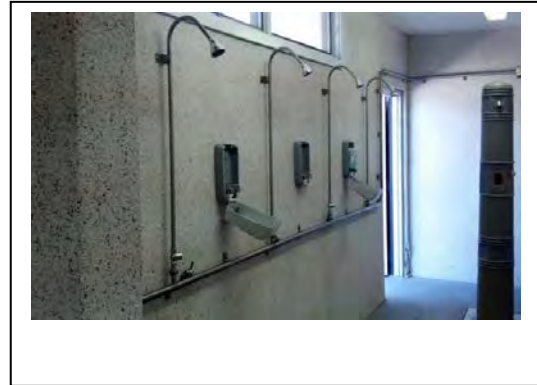
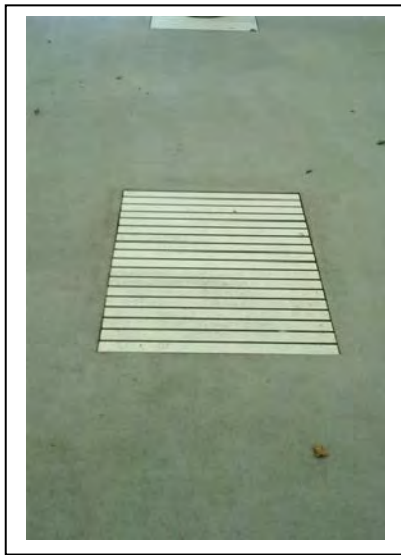
- o Men's Shower Room consists of eight (8) shower valves with heads, two (2) floor drain grate systems.

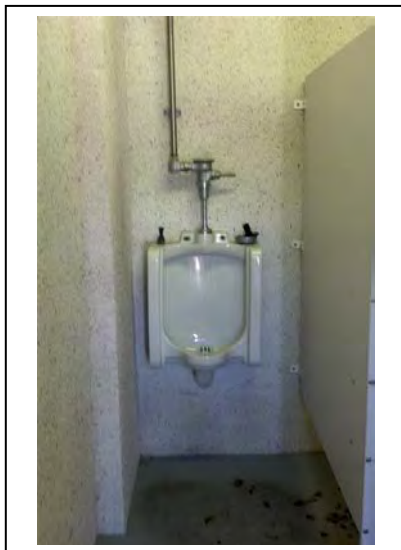
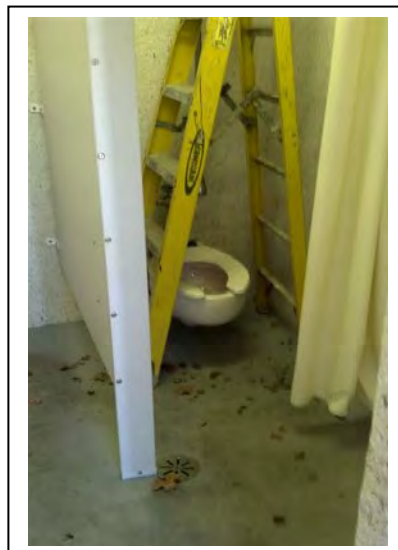
- o Men's Wet Toilet Room consists of one (1) wall hung flush water closet with manual flush valve, one (1) urinal with manual flush valve and one (1) one floor drain.

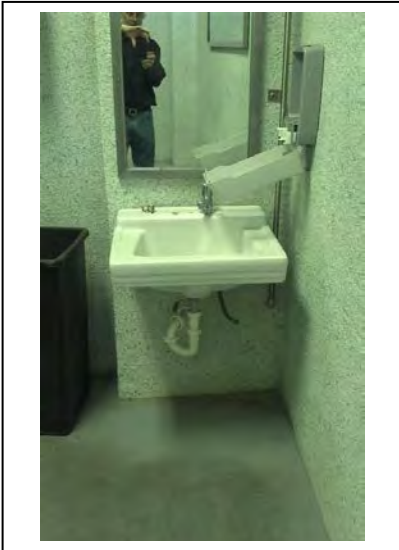
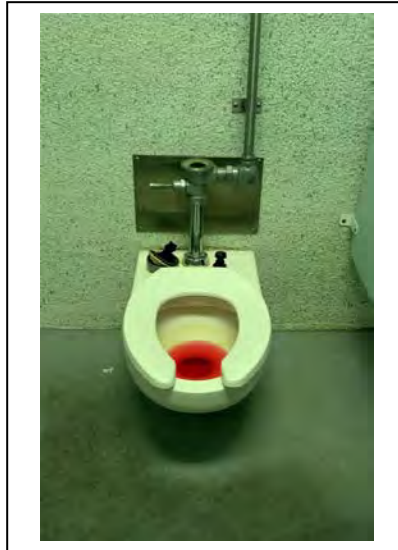
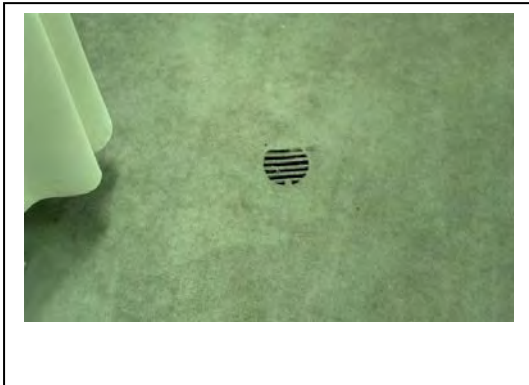
- o Women's Locker Room consists of one (1) hose bibb and three (3) floor drains.
- o Women's Dry Toilet Room consists of one (1) wall hung china lavatory with single handle faucet, two (2) wall hung water closets with manual flush valves and one (1) floor drain.

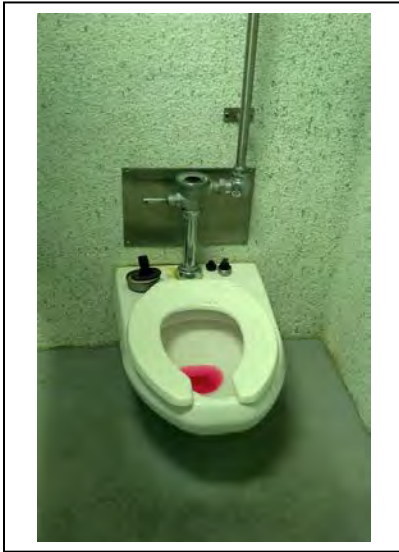
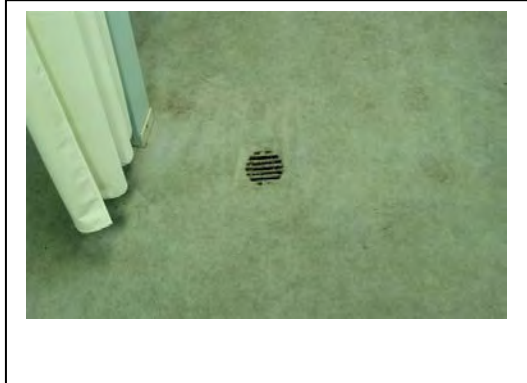
- o Women's Wet Toilet Room consists of one (1) wall hung flush water closet with manual flush valve and one (1) one floor drain.

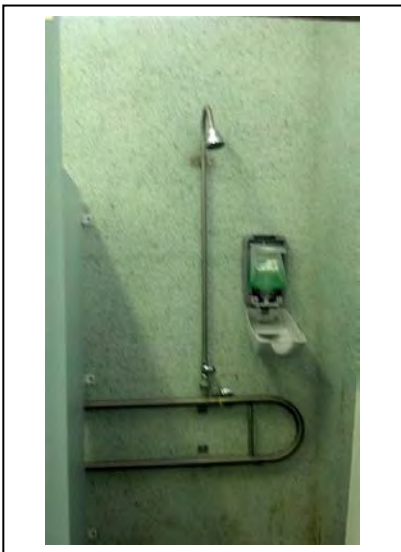
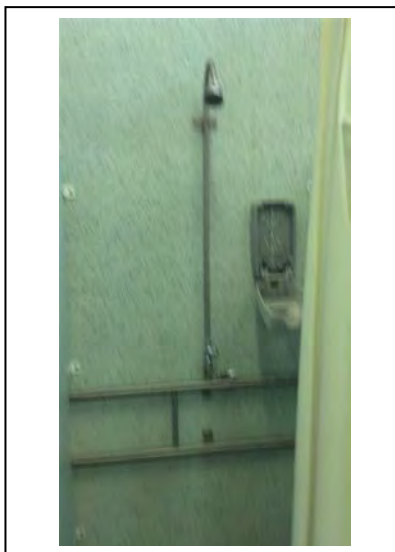
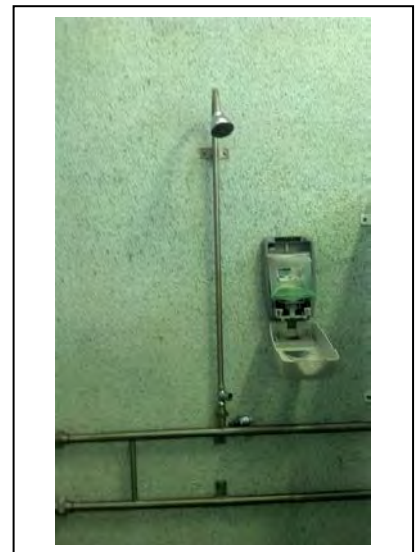
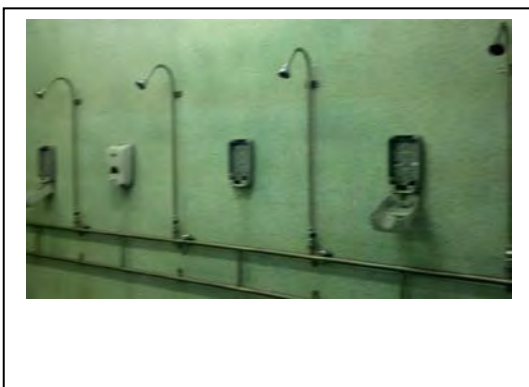
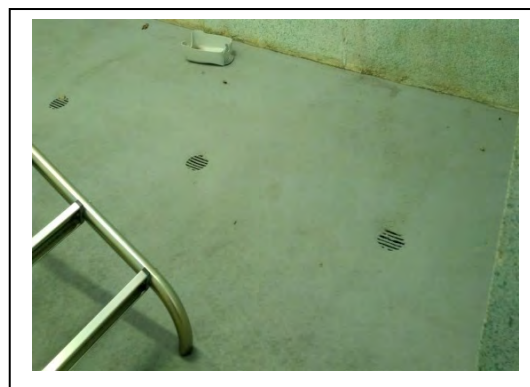
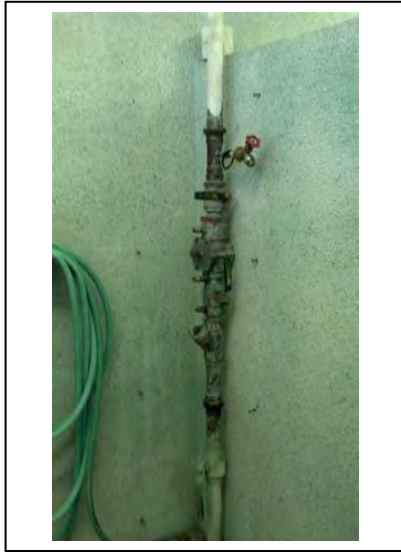
- o Women's Shower Room consists of seven (7) shower valves with heads, seven (7) floor drains and one (1) one 2" RPZ with no meter.

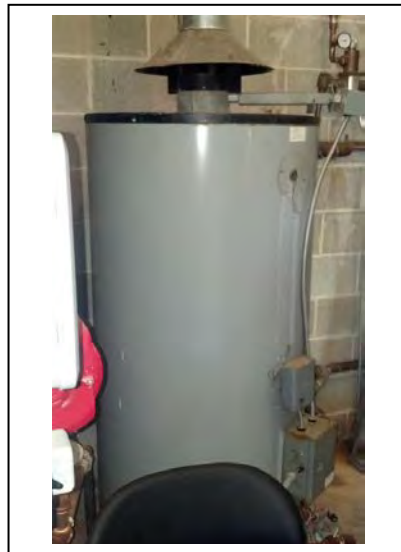
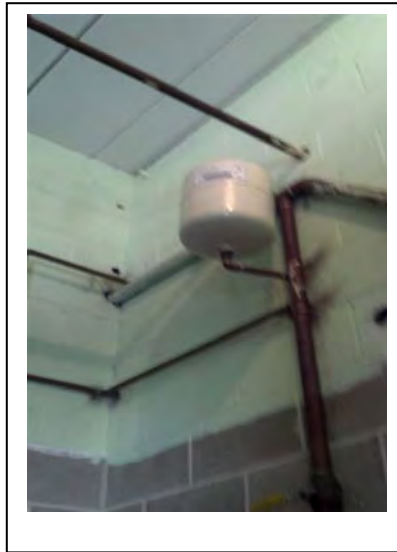
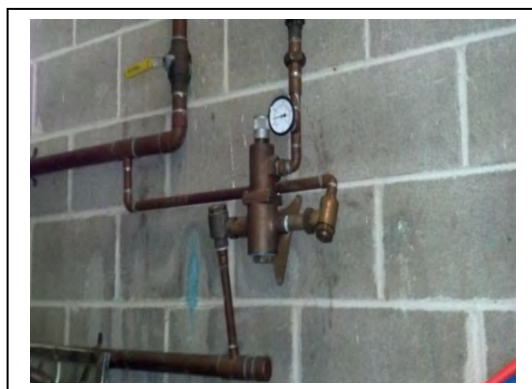
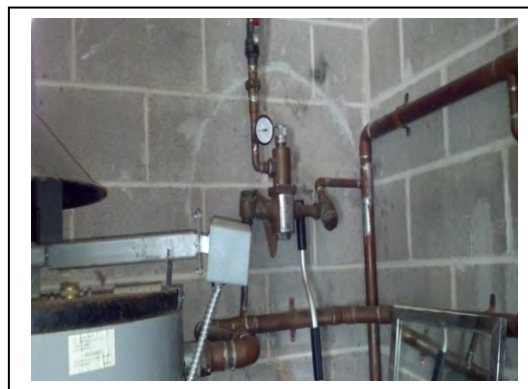
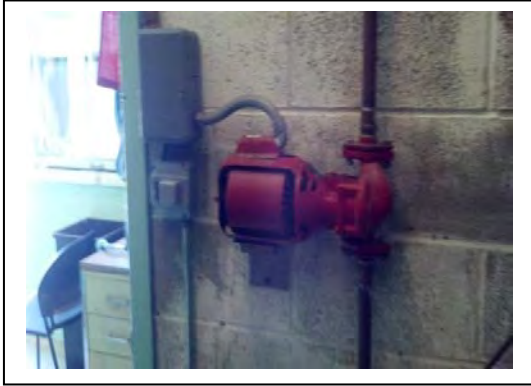
- o Mechanical Room consists of one (1) 199,000 80 gallon gas fired water heater, one (1) expansion tank, one (1) recirculation, two (2) mixing valves and one (1) floor drain.

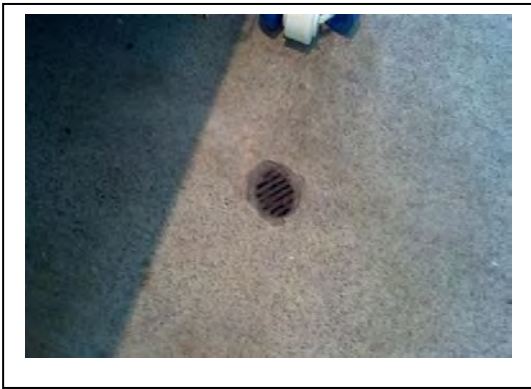
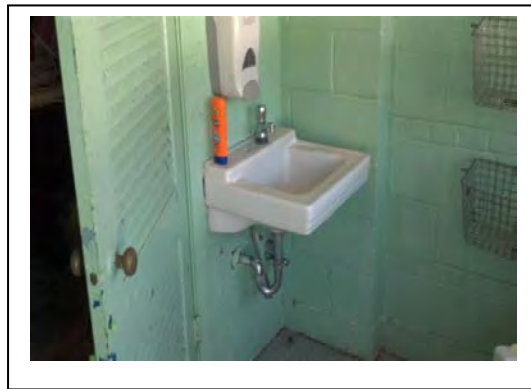
- o Guard Room consists of one (1) wall hung china lavatory with single handle faucet and three (3) floor drains.

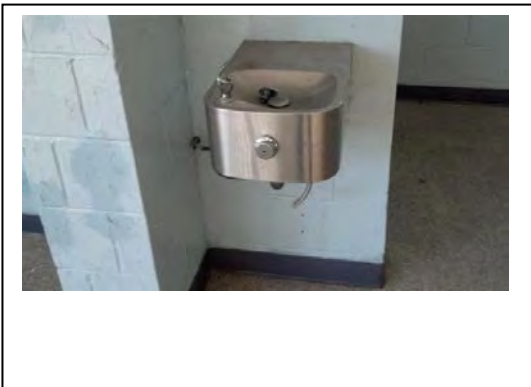
- o Entry consists of one (1) single level drinking fountain.

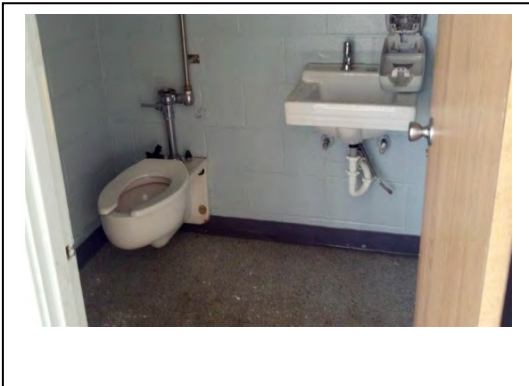
- o Women's Toilet Room consists of one (1) wall hung water closet with manual flush valve, one (1) wall hung china lavatory with metering faucet and one (1) floor drain.

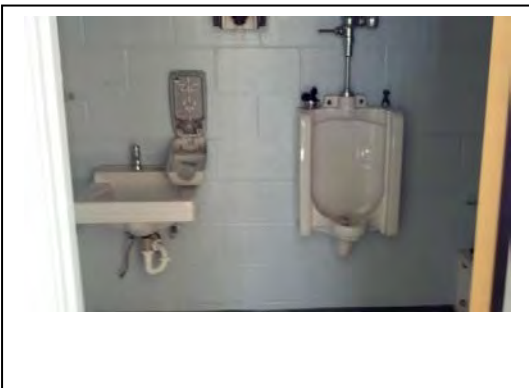
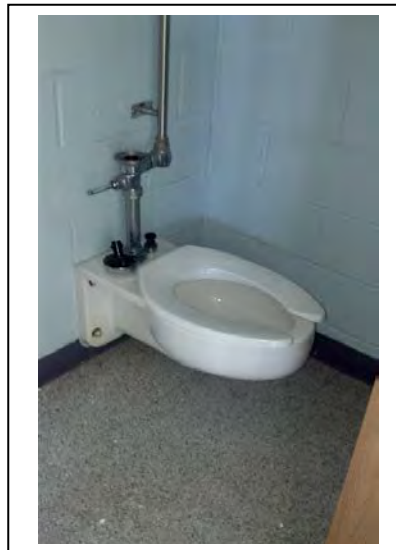
- o Men's Toilet Room consists of one (1) wall hung water closet with manual flush valve, one (1) urinal with manual flush valve, one (1) wall hung china lavatory with metering faucet and one (1) floor drain.

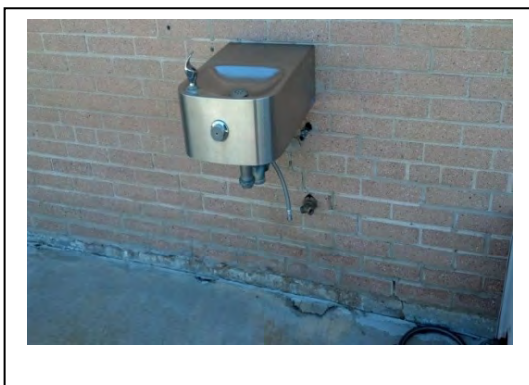
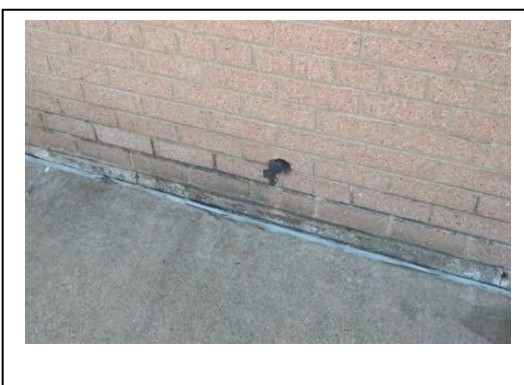
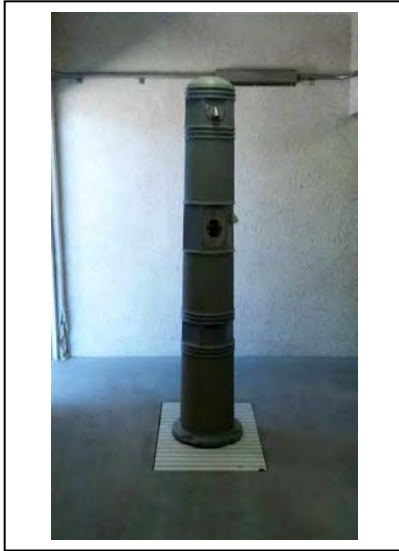
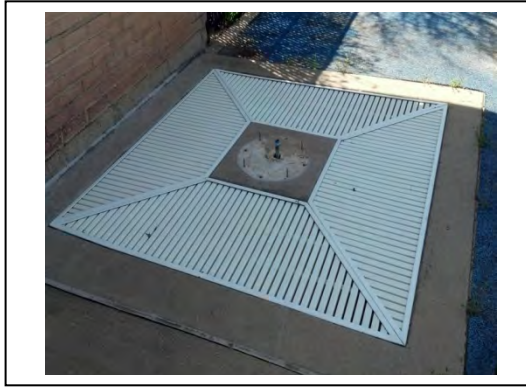
- o Bathhouse Exterior consists of one (1) stainless steel drinking fountain, two (2) hose bibs and one (1) shower tower with drain.

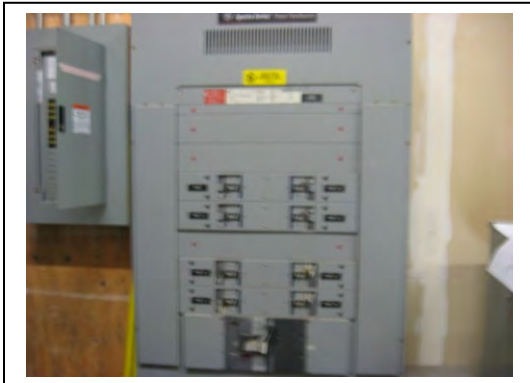
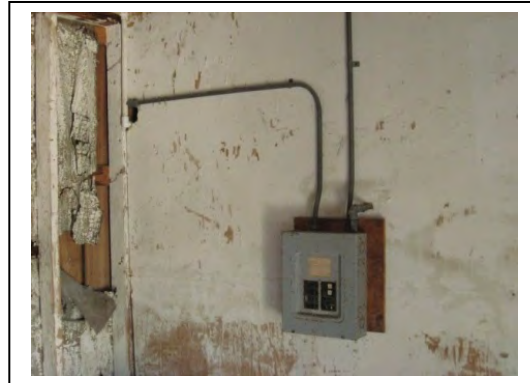
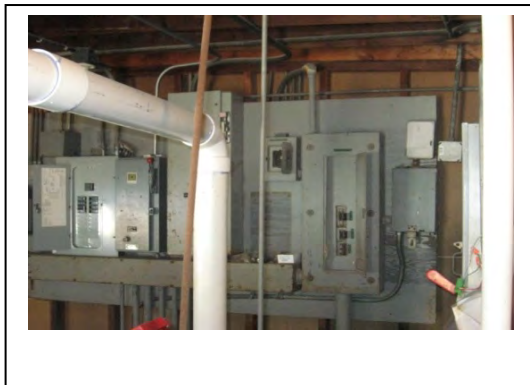
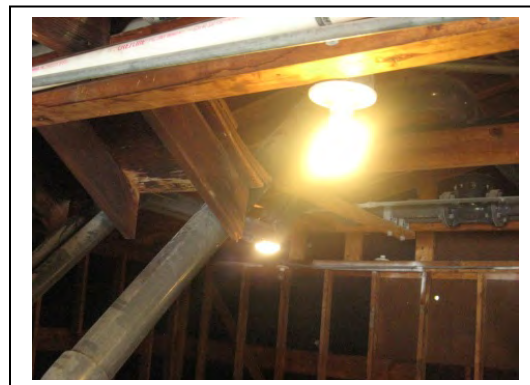
- Filter Building
  - o The existing electrical service meter and C/T are mounted on the wall of the pool Filter room, within main electrical panel located in the Pool Filter Room. The electrical service is 1200 AMPS, 120/208V, 3-phase, 4-Wire. The service is sufficient and all electrical equipment are in good condition except for minor rust spots on some equipment enclosures. The main Panel feeds a single- phase, 100 Amp, 3W panel that is feeding the building on the other side of the pool. The lighting consists of porcelain sockets with incandescent lamps. Existing abandoned energized panel mounted on the wall with exposed wires.
  - o All interior lighting is controlled with wall switches.
  - o Receptacles are present and fed from 20A circuits.
  - o No fire alarm present.
  - o No Exit and EM battery lights present.

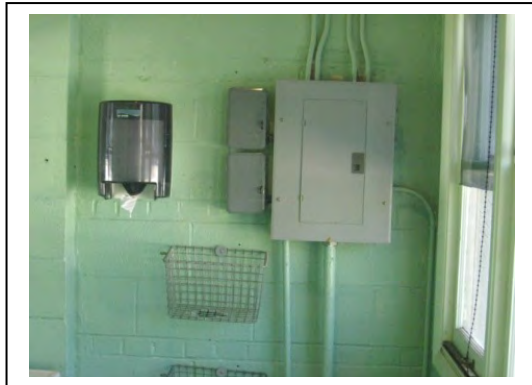
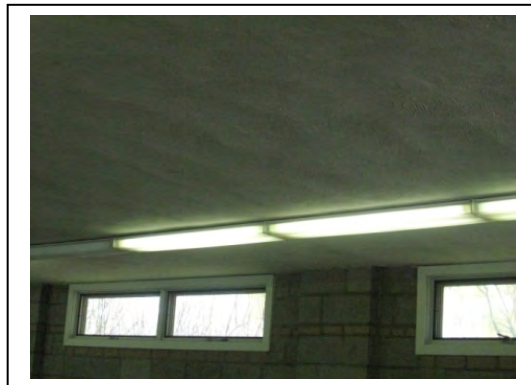
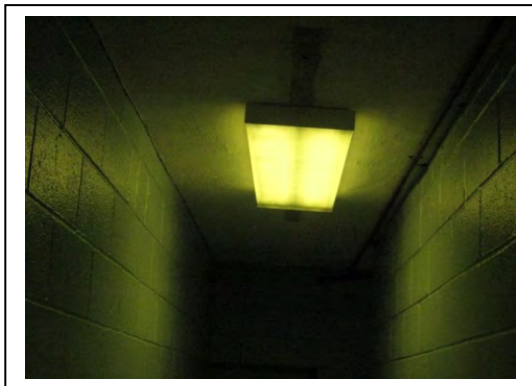
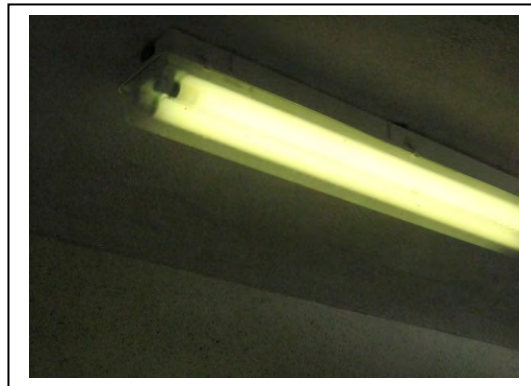
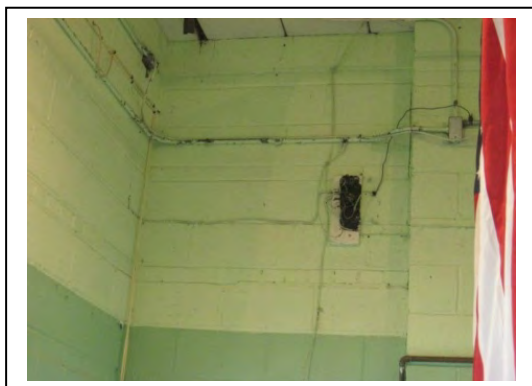
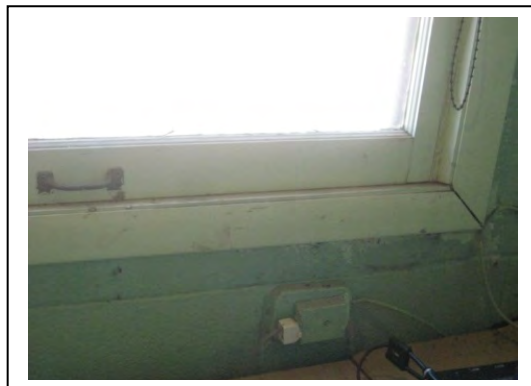
- Bathhouse
  - o All lighting and receptacle power in this building is fed from a 100Amp, 120/208V, 1-phase, 3W panel that is fed from the main panel in the Filter Building.
  - o Lighting in the storage area where the panel is located consists of 4' strip light fixtures with (2) T8 lamps.
  - o The rest of the building including the toilets, locker rooms, shower areas for both men and women and corridors consists of 4 ft. wraparound fluorescent ceiling fixtures.
  - o All interior lighting is controlled by wall switches.

- Condition of System
  - o Electrical panels are in average condition in general.
  - o The capacity of the electrical service is adequate.
  - o The interior lighting fixtures are in average to poor condition in both buildings.
  - o Receptacles range from average to good condition
    - Exterior lighting is in average condition but does not meet dark sky friendly code requirements.
    - All receptacles are in poor conditions.
    - Abandoned energized equipment on the wall with exposed wires.
- Code Violations
  - o No EM or Exit lighting.
  - o Receptacles within 6' of water not GFCI protected.
  - o Receptacles outside not GFCI protected & weatherproof.
  - o Open boxes on the walls were noticed.
  - o GFCI receptacles are not present anywhere in both buildings even within 6' from water.
  - o Exit and emergency lighting are not present.
  - o Fire alarm system is not present.

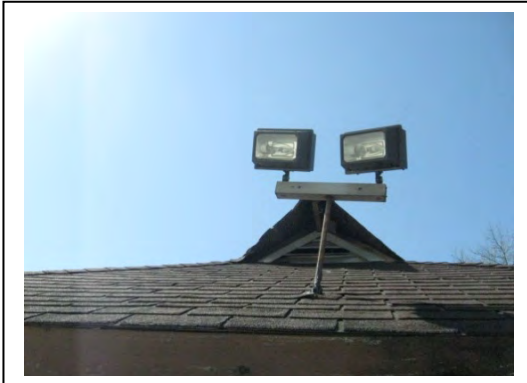
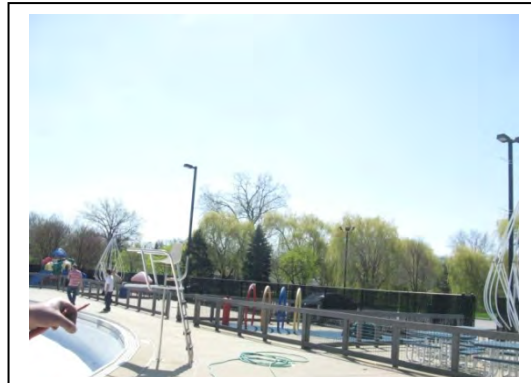
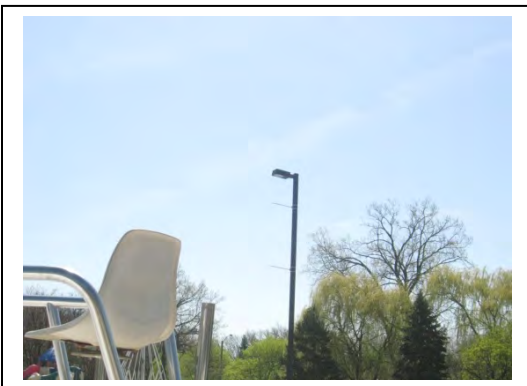
- Exterior
  - o Based on visual observation, exterior lighting consists of:
    - Wall mounted incandescent fixtures around the exterior walls of both buildings and (2) fixtures mounted on the roof of the Filter Building pointed to the pool.
    - HID shoe box Headfixtures mounted on 30' poles around the pool.
  - o Half of the poles are controlled from the panel in the filter building and the other half controlled by from the panel in the bathhouse.

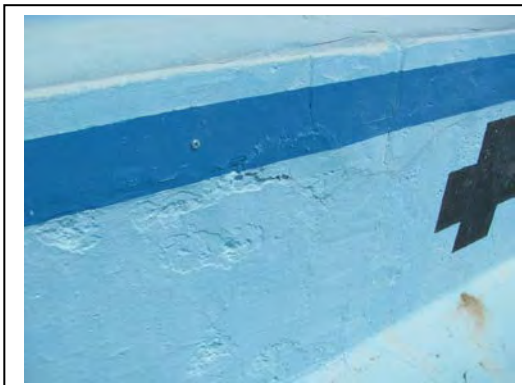
**Photo # 19**

1. The pool structure has significant deterioration. The pool walls and floor have cracking and spalling throughout the pool structure. Hollow spots were found in the pool structure. Refer to photos #19 and # 20.

| | <u>Recommendation</u> | <u>Priority</u> | <u>Probable Cost Range</u> |
|---|---|---|---|
| 1. | Remove existing pool liner and repair deteriorating pool concrete structure. (assume 50% of wall/floor surface, 4,030 sq. ft.) | 1 | \$160,000 to \$320,000 |

1. Pool liner would need to be removed and entire pool walls and floor inspected to determine extent of repairs. For purposes of this report we have assumed 50% of the wall/floor surface will require some type of repair.

2. Pool structural repairs may range from epoxy injection of cracks to complete removal of deteriorated concrete, installation of stainless steel reinforcement, application of bonding agent and regrouting.

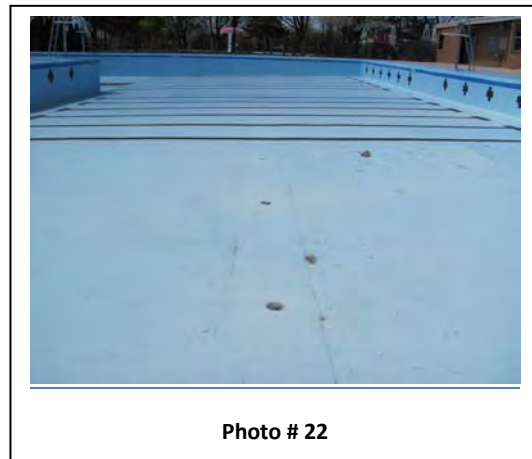
3. Staff was questioned about pool water loss. Staff indicated that the pool is losing 2" of water in less than 24 hours.
4. The pool utilizes floor inlets which run down the center of the pool. This design does not provide an even distribution of filtered chlorinated water. Refer to photo #22. *This is a violation of current IDPH code requirements: Section 820.210.f.2.- E) Where floor inlets are used, inlets shall be uniformly spaced at a distance of no greater than 20 feet apart, and rows of inlets shall be within 15 feet of each side wall. Floor inlets shall be flush with the pool floor and shall include a diffuser plate to evenly distribute the flow in all directions.*
