## FACILITY EVALUATION

Date: 24 September 2013

PROJECT NAME: Facility Evaluation  
Lufkin & Jefferson Pools

WA PROJECT NUMBER: 2013-010

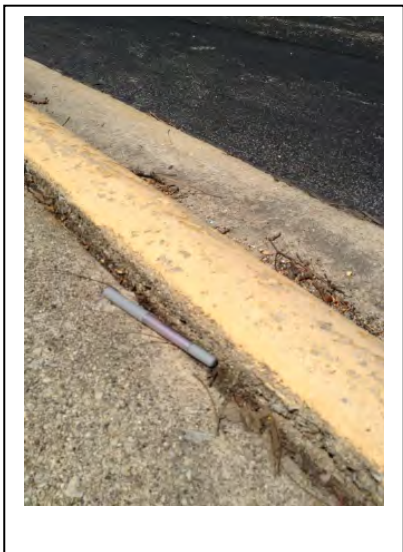
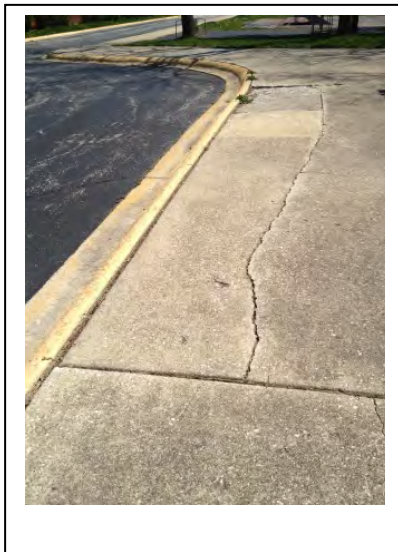
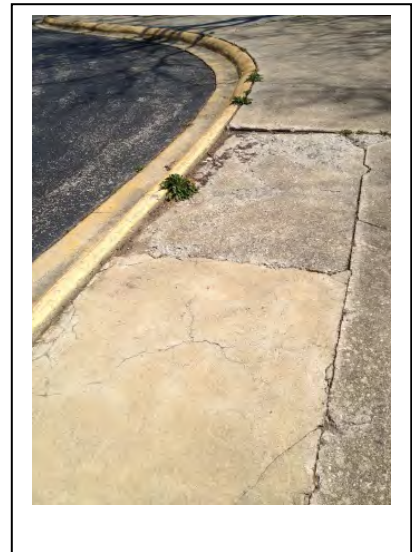
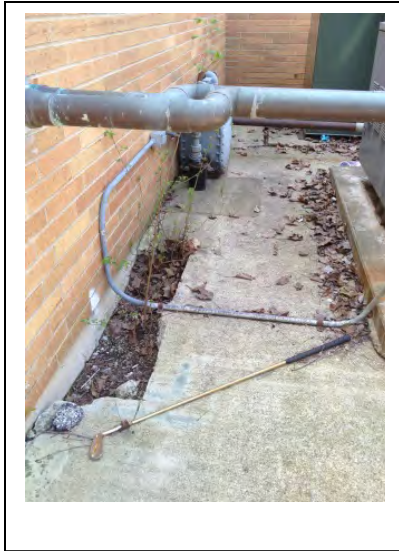
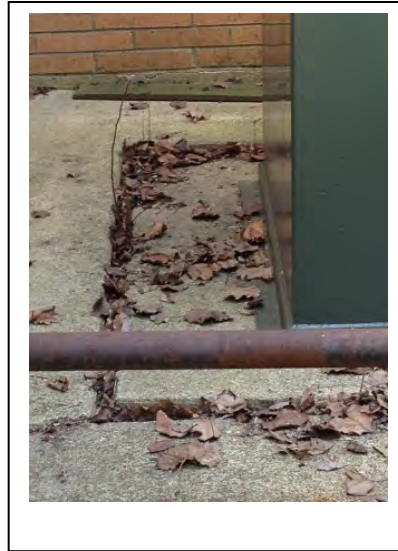
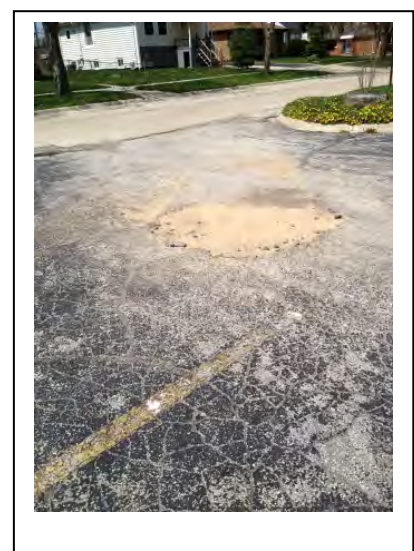
- Parking Lot
  - o The parking lot and drives are asphalt.
  - o The drive is in fair condition and the parking lot in fair to poor condition with many areas exhibiting significant alligator cracking and in some instances missing asphalt.
  - o Lot should be resurfaced in the near future to avoid further, more significant deterioration.
  - o The drive is in fair condition and should have cracks repaired and be sealcoated.
  - o Concrete curb – in fair condition.
  - o Concrete walk – walk in front of building is in poor condition with significant cracking and settling.
  - o Concrete slab under pool heater has settled. Missing concrete in the enclosure.

| <u>Recommendation</u> | <u>Priority</u> | <u>Probable Cost Range</u> |
|---|---|---|
| • Repair cracks, sealcoat and restripe | 2 | \$4,000 to \$4,500 |
| • Replace damaged or missing wheel stops | 2 | \$1,000 to \$1,500 |
| • Replace concrete apron in R.O.W. (600 SF) | 2 | \$8,000 to \$10,000 |

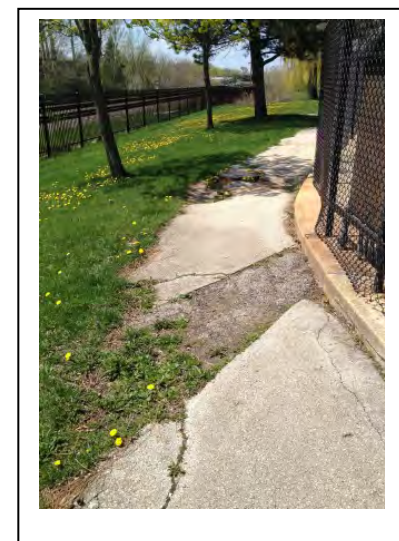
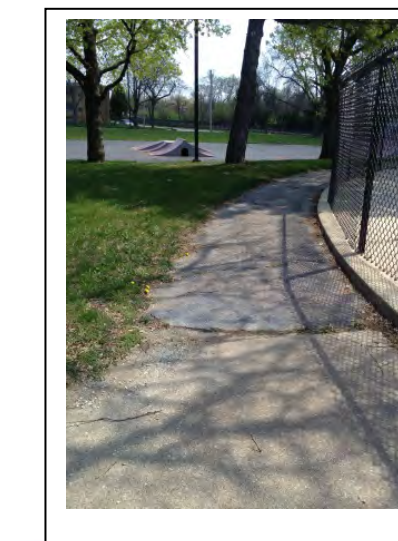
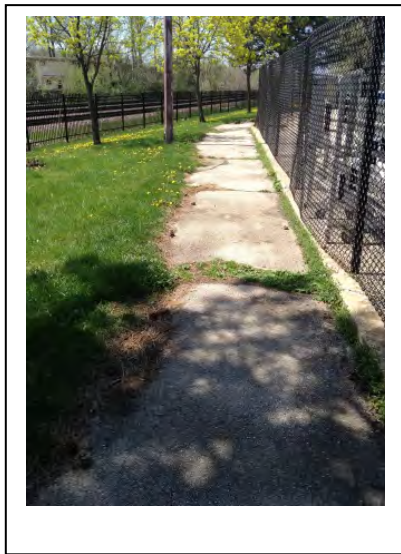
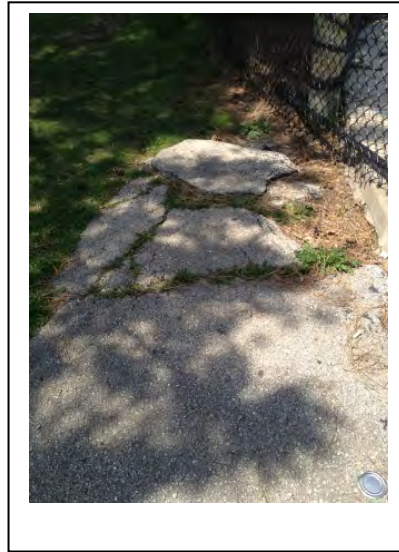
- o Perimeter walk – walk along outside of pool fence is asphalt and in poor condition exhibiting settling, weed growth and overall deterioration.

| <u>Recommendation</u> | <u>Priority</u> | <u>Probable Cost Range</u> |
|---|---|---|
| • Replace damaged and settled portions of walk (allow 200 SF) | 1 | \$2,000 to \$3,000 |

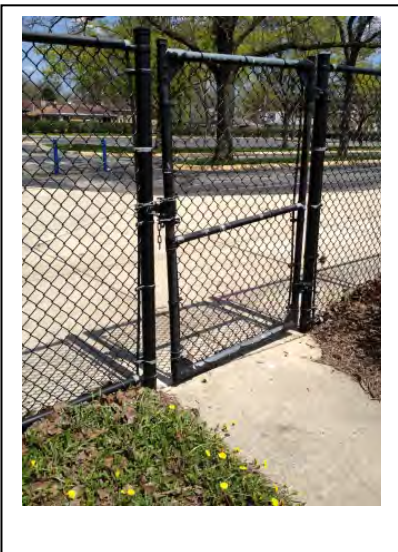
- o Pool Fence – chain link fence in fair condition.

| 13. | Replace existing perimeter fencing (based on 580 linear feet) | 2 | \$24,000 to \$26,000 |

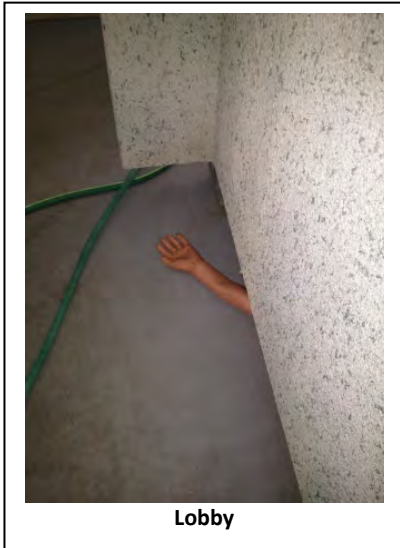
- Lobby
  - o Floor – epoxy in fair condition.
  - o Walls – painted plaster in fair to good condition.
  - o Ceiling – painted metal panels in generally good condition.

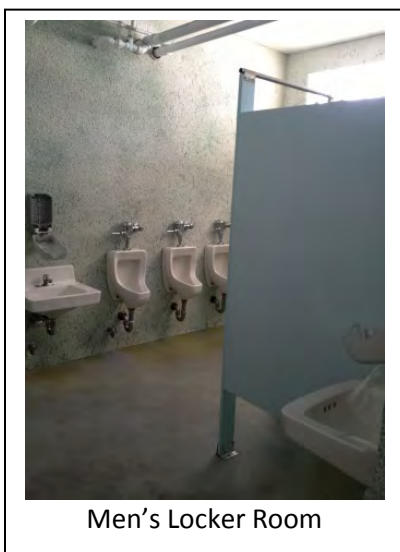
- Men's Locker Room
  - o Floors – epoxy in fair condition.
  - o Walls – painted plaster in fair to good condition.
  - o Ceiling – painted metal panels in generally good condition.
- Women's Locker Room
  - o Floors – epoxy in fair condition.
  - o Walls – painted plaster in fair to good condition.
  - o Ceiling – painted metal panels in generally good condition.

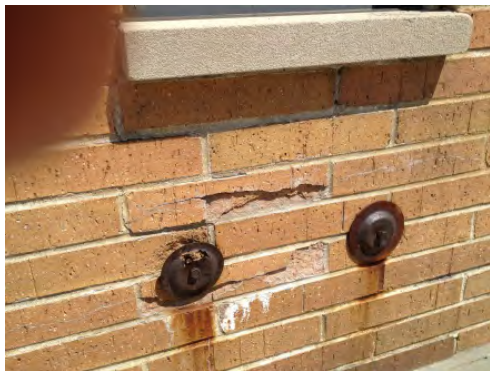
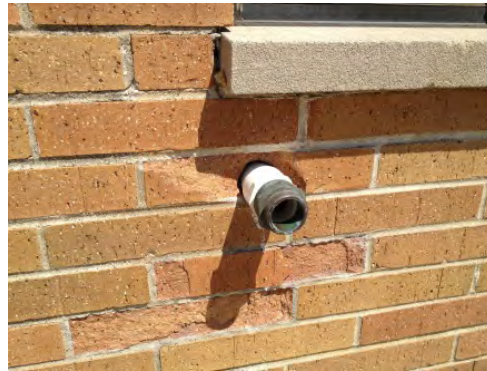
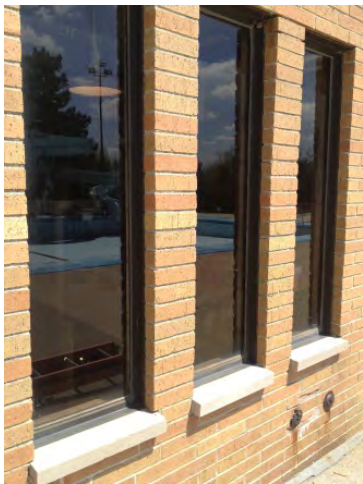
South Wall

- Bathhouse – Exterior
  - o Walls
    - Face Brick
      - South wall has spalling brick, loose / missing mortar (10% to 20% of wall surface).
      - East wall – good condition except for two small holes.
      - North wall – good condition.
  - o Soffits – painted roof plank – rusting at south wall, otherwise in good condition. Some flaking paint along north side of building.
  - o Fascia – painted metal.
    - South side in fair to poor condition. One section has been replaced and is a different color. Soffit is dented and sagging and has rusted fasteners.
    - Balance of fascia is in fair to good condition.

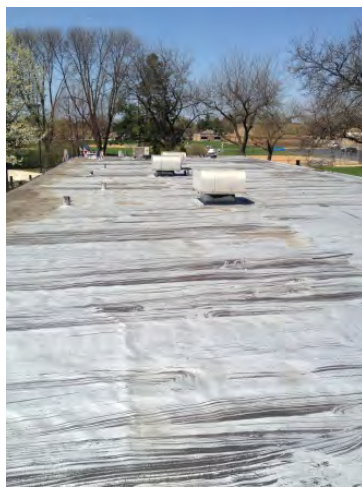
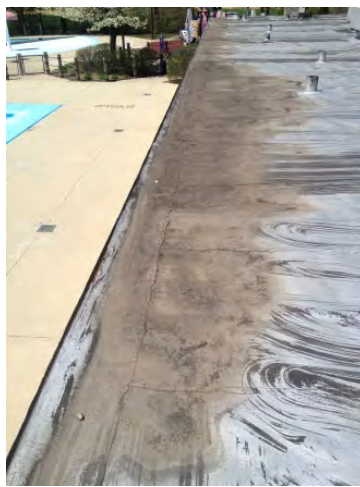
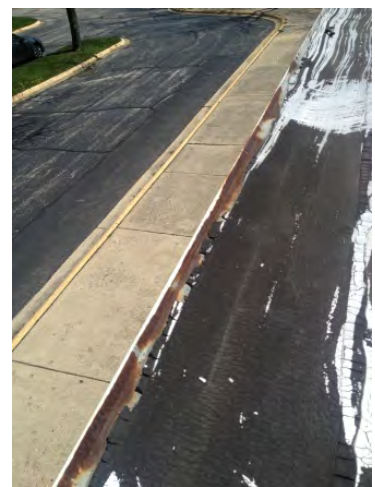
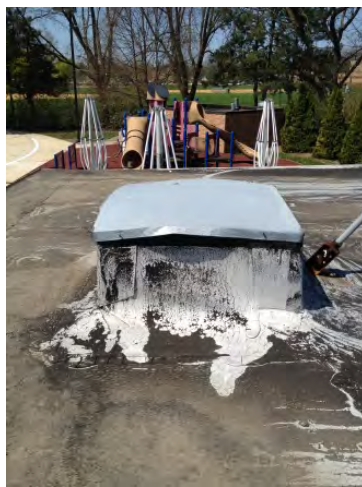
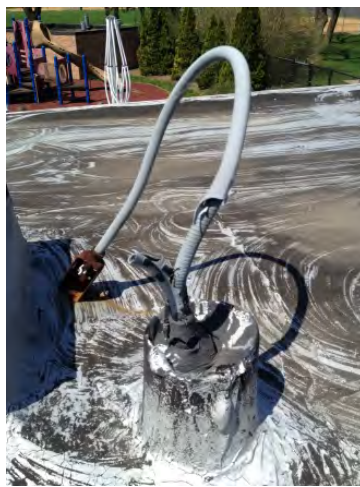
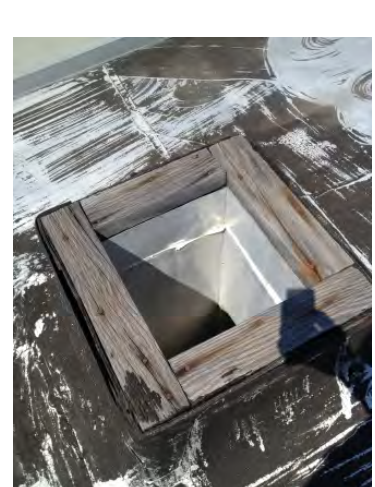
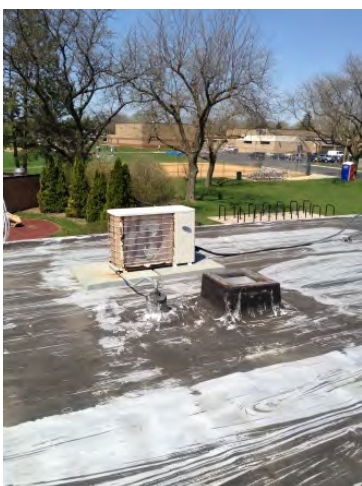
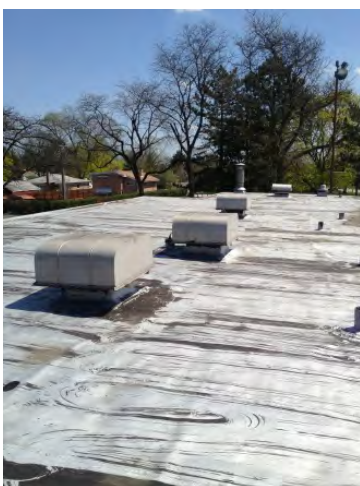
- o Roof
  - Asphalt painted silver in poor condition

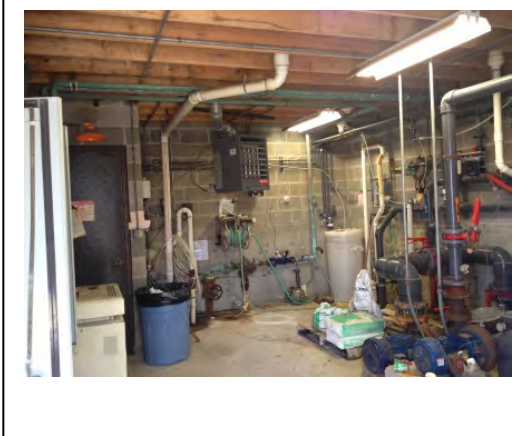
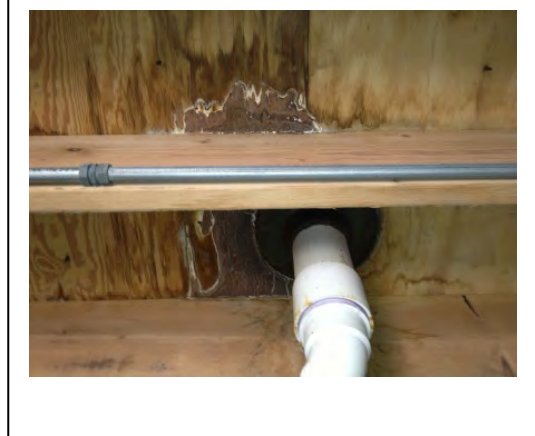
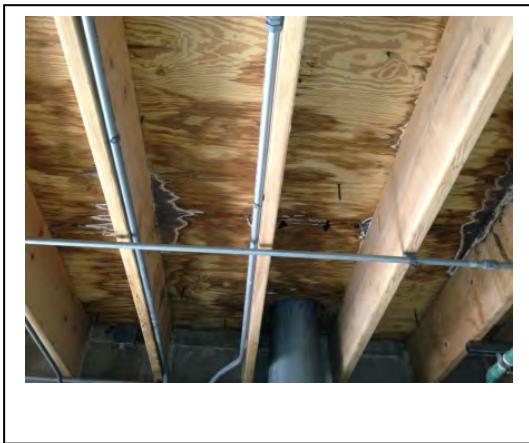
- New Filter Building at Tot Pool
  - o Interior
    - Exposed concrete slab on grade – good condition.
    - Unpainted concrete block walls – good condition.
    - Exposed Wood Roof – good condition.
    - Water stained which is indicative of leak.

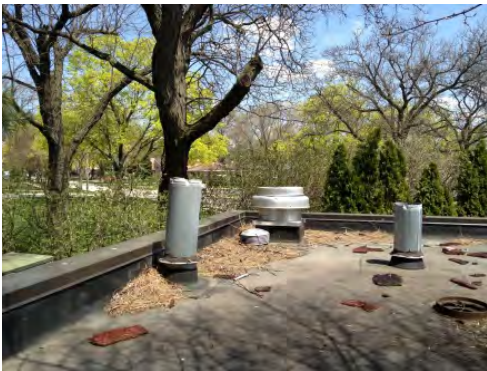
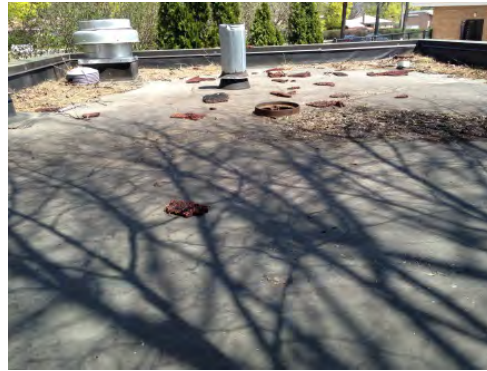
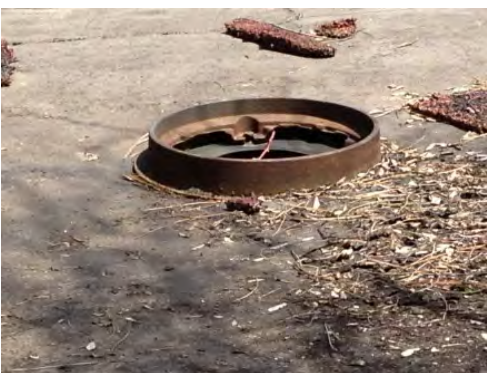
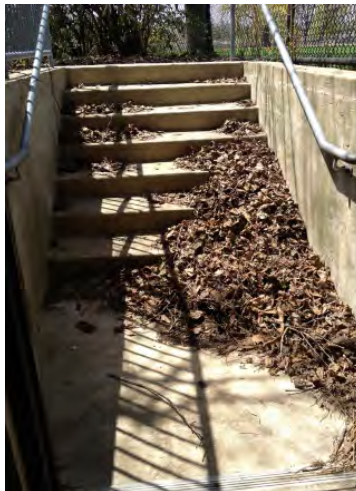
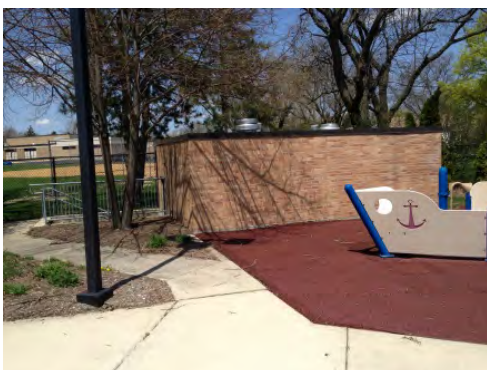
- Brick Walls – good condition.
- Aluminum Coping – good condition.
- Roof – rubber membrane – good condition.
  - Missing vent caps and drain cover – should be replaced. Much debris – should be cleaned to prevent deterioration.
- Door – FRP with aluminum frame – good condition.
- Exterior stair – good condition.
  - Evidence drain at base of stair is clogged, most likely due to leaves. Should be cleaned and checked to be sure it drains properly to avoid water back-up into floor of building.
- Stair railing – galvanized steel in good condition – showing signs of minor rusting.

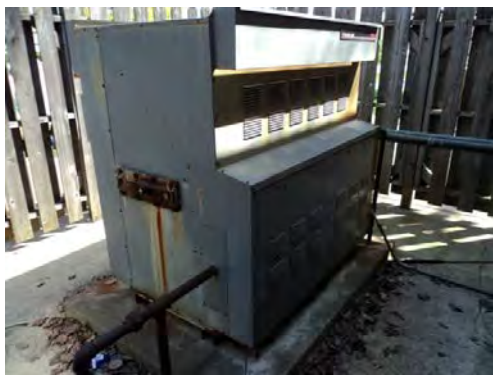
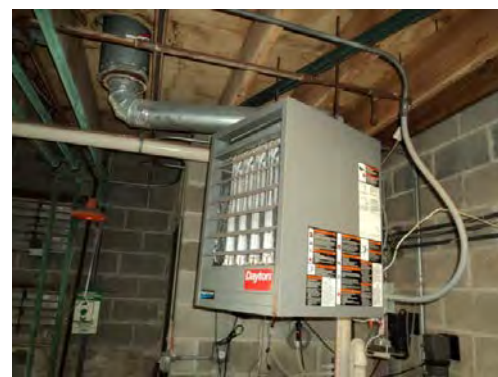
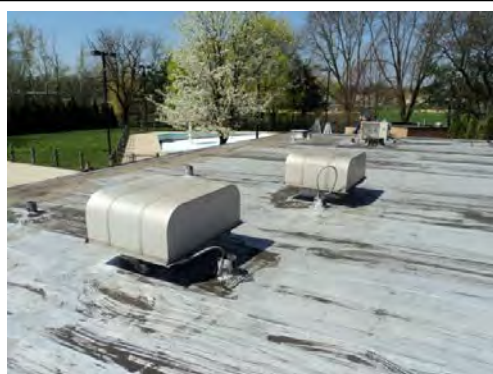
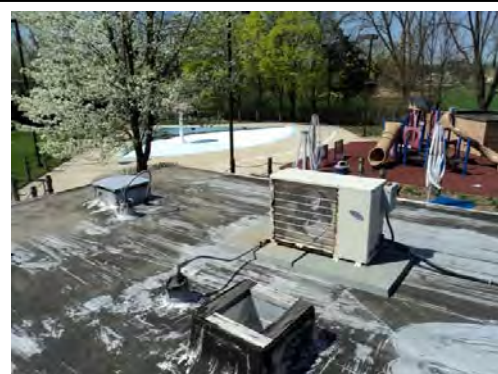
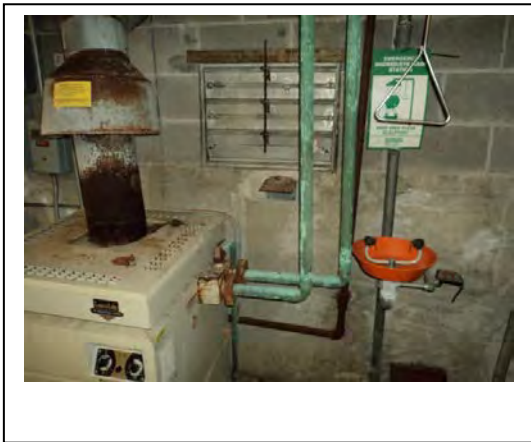
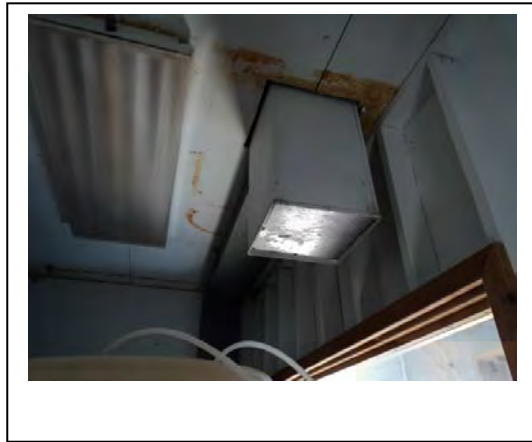
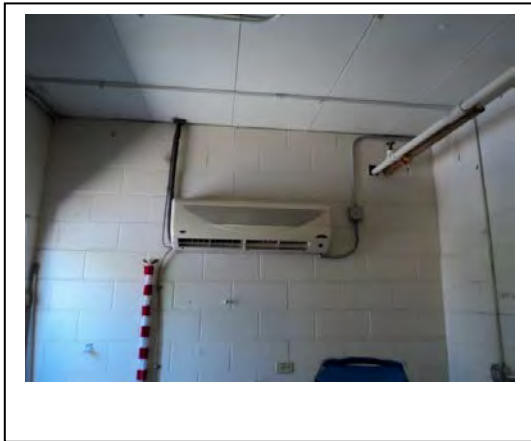
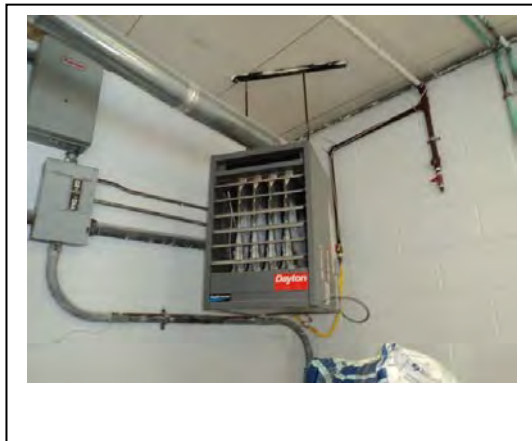
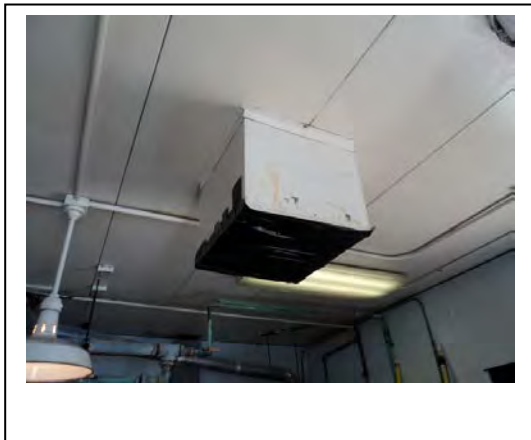
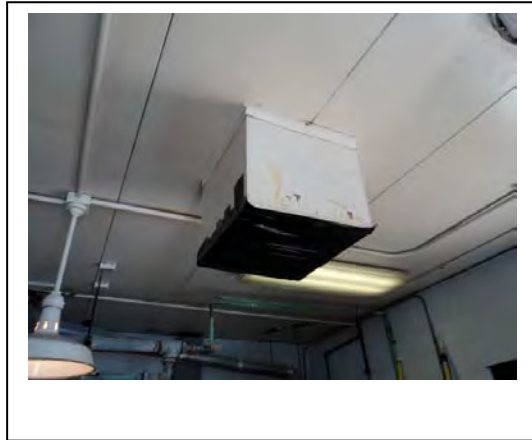
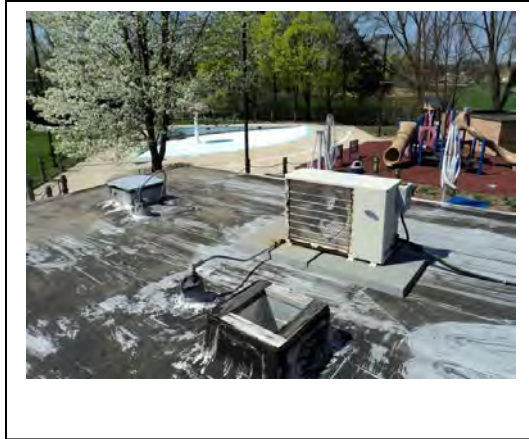
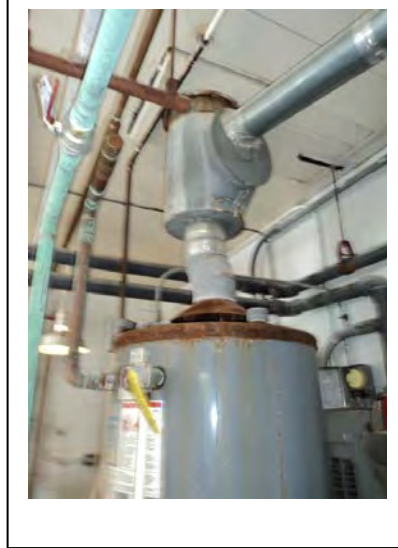
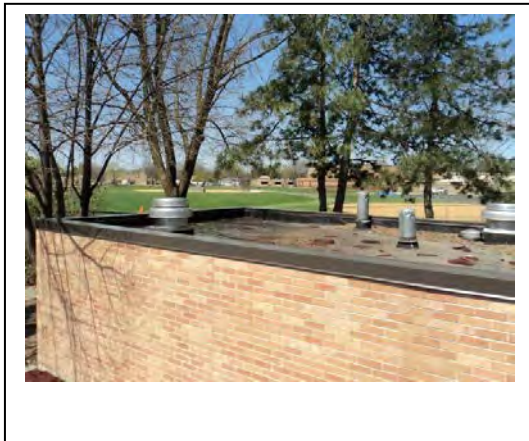
- Bathhouse /Filter Building
  - o Gas fired unit heater in pool equipment room is in good condition.
  - o Pool heater mounted at grade outside of pool equipment room is in poor condition.

- o Aluminum exhaust and intake ductwork in chemical storage room has some corrosion, however is in fair condition.
  - o Excessive corrosion on flue piping and water heater in equipment room.

- o Supply hoods and exhaust fans on roof appear to be in fair to poor condition.
  - o Exhaust fan serving the concession room is removed and roof opening is open to the weather, see photos

- o Wall mounted ac unit serving concessions appears to be in good condition. The associated condensing unit is in fair to poor condition. It is reported that this system is not used.

- Spray Pad Filter Building
  - o Pool heater flue badly corroded as are most metal surfaces in the room.
  - o New electric unit heater is in good condition.

- o Gas fired unit heater is in good condition. Staff reported it will soon be removed to save from corrosion.
  - o Coated exhaust ductwork in chemical storage room is in fair condition, door grille for intake corroded.

- o Roof mounted exhaust fans are in fair condition.
  - o Vent caps from pool heater and unit heater have been removed and roof openings are exposed to weather, see photos.

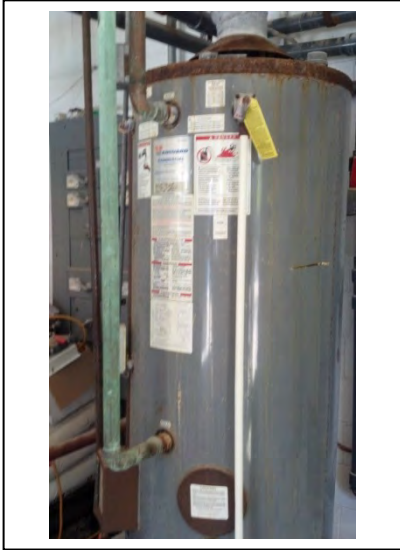
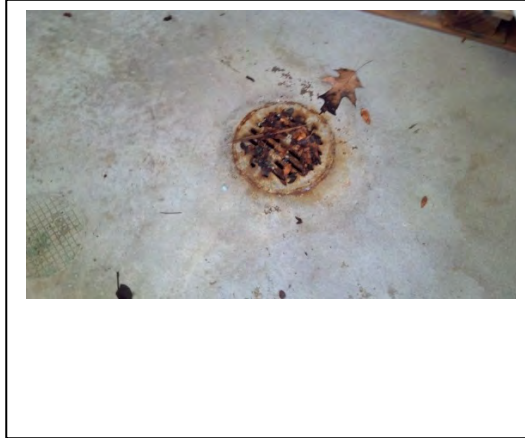
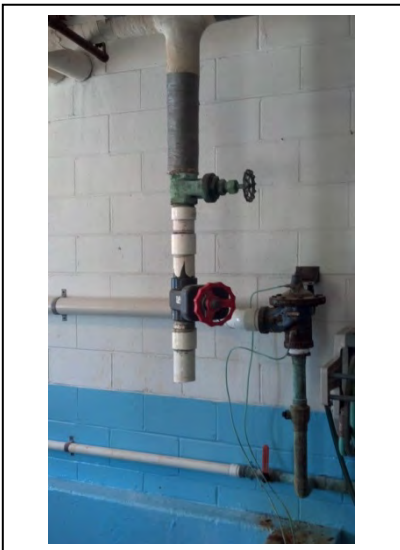
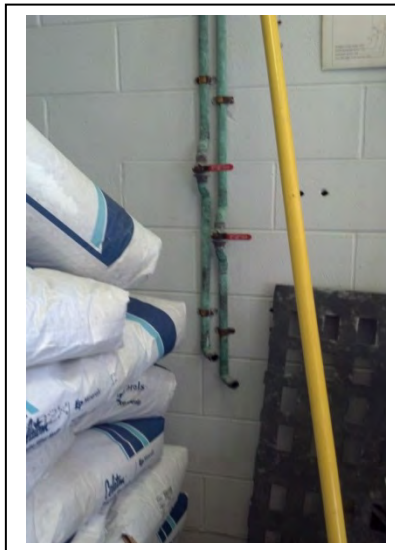
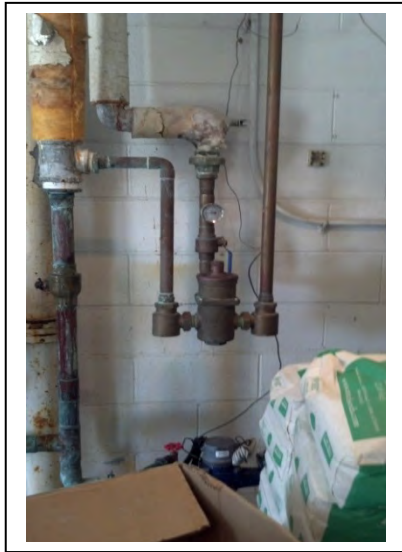
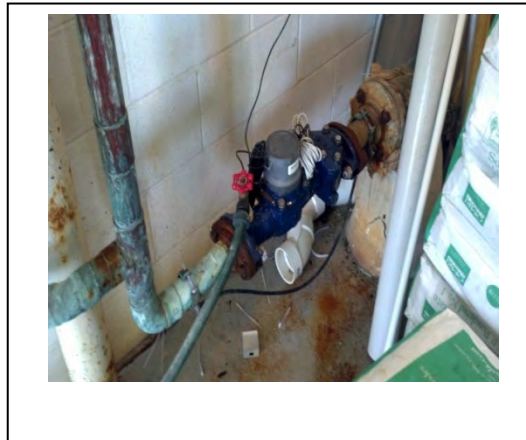
- Equipment Room consists of one (1) 199,00 BTU 81 gallon gas water heater, one (1) thermostatic mixing valve, one (1) 3" water main, one (1) 2" water meter and valving, one (1) hose bibb and one (1) floor drain.

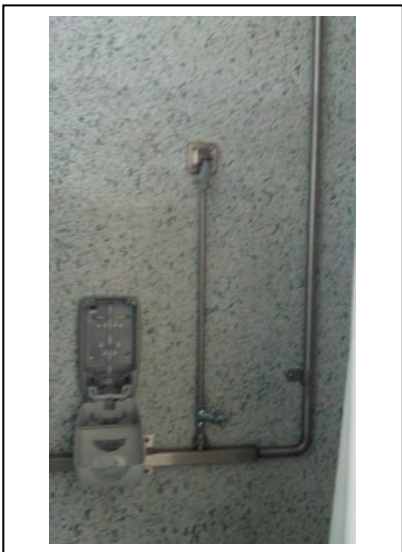
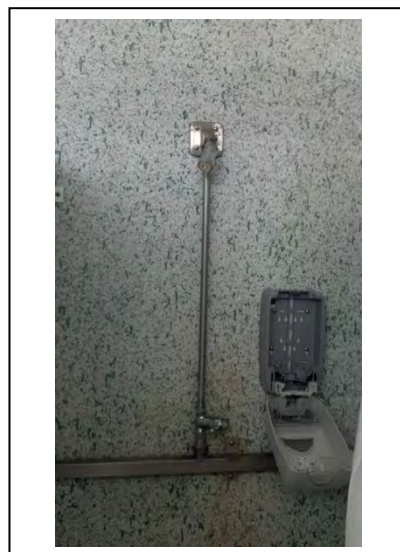
- o Women's Wet Toilet Room/Shower room consists of seven (7) shower valves with heads, two (2) trench drains, two (2) floor set manual flush valve water closets and on (1) floor drain.

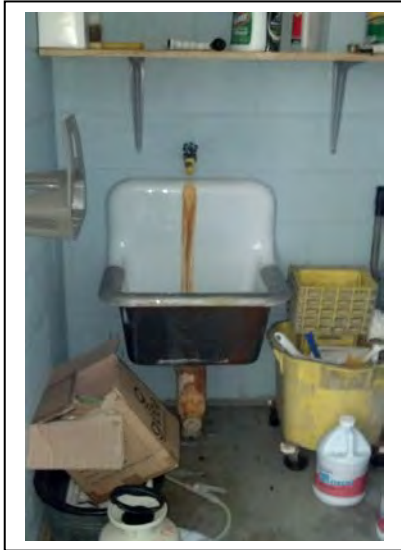
- Janitor Closet consists of one (1) service sink with hose bib for faucet.

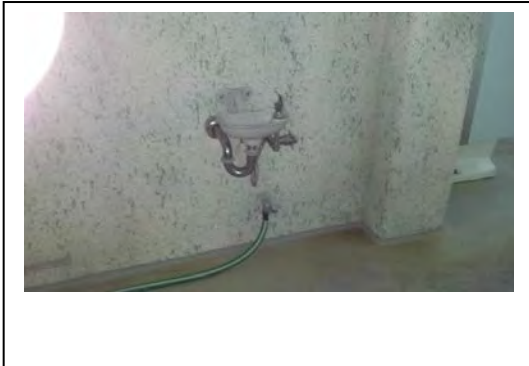
- Women's Locker Room consists of two (2) floor drains, one (1) drinking fountain and one (1) hose bibb.

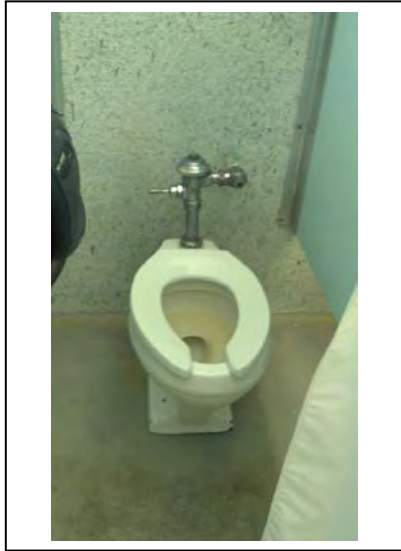
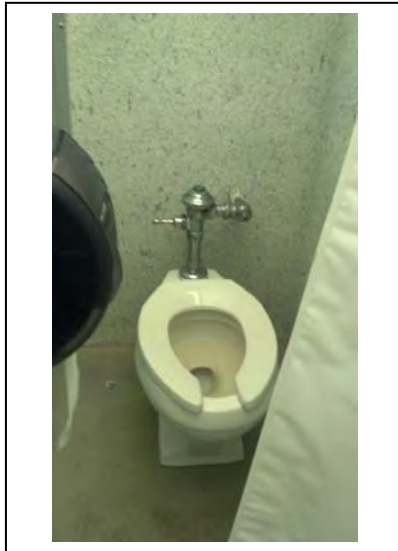
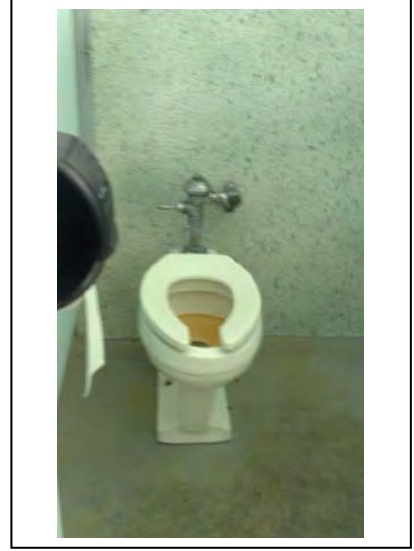
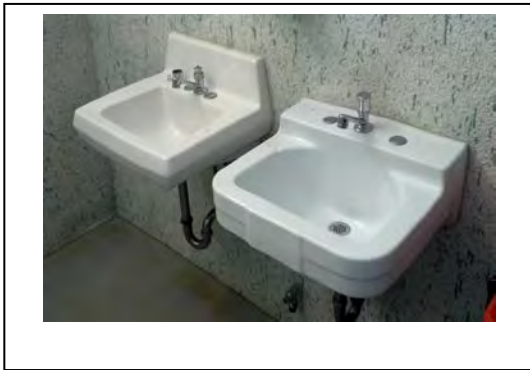
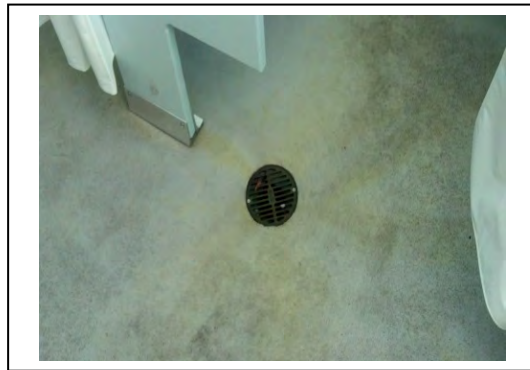
- Women's Dry Toilet consists of three (3) floor set manual flush valve water closets, two (2) wall hung china lavatories with metering faucets, one (1) hose bibb and one (1) floor drain.

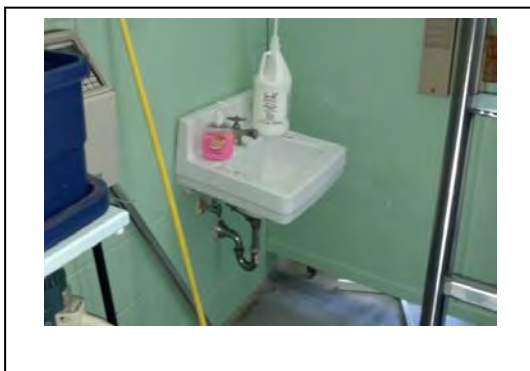
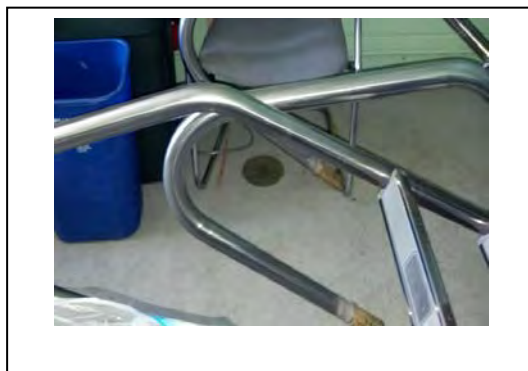
- Guard Room consists of one (1) wall hung china lavatory with metering faucet and one (1) floor drain.

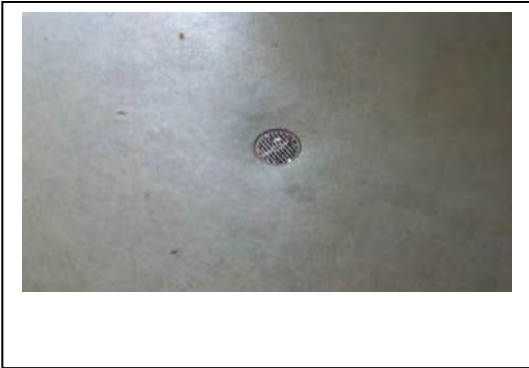
- Entry consists of one (1) floor drain.

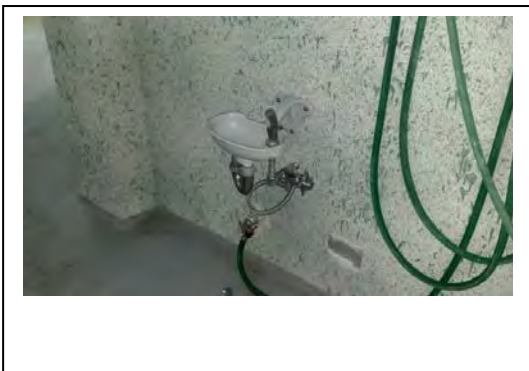
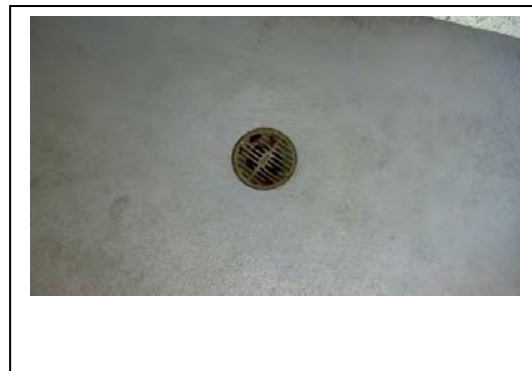
- Men's Locker Room consists of one (1) drinking fountain, two (2) floor drains and one (1) hose bibb.

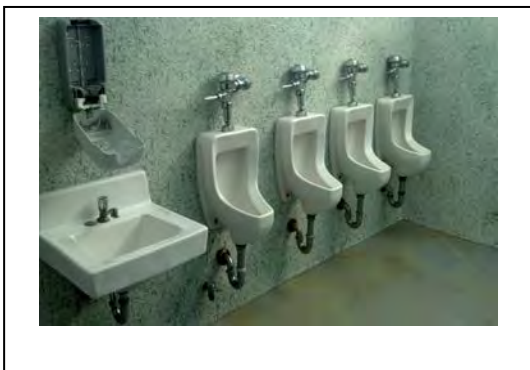
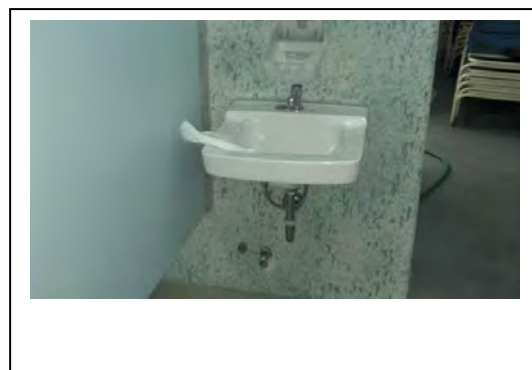
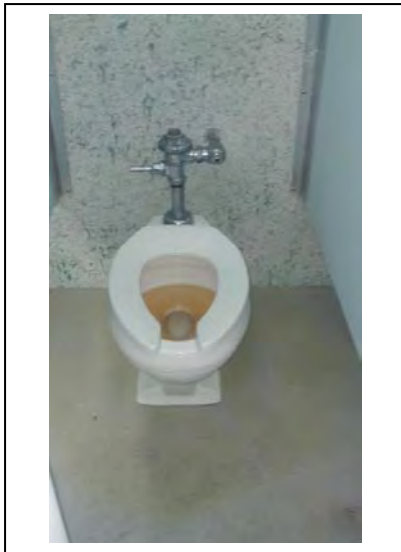
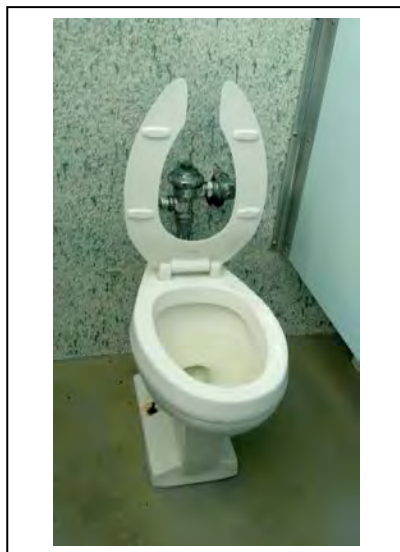
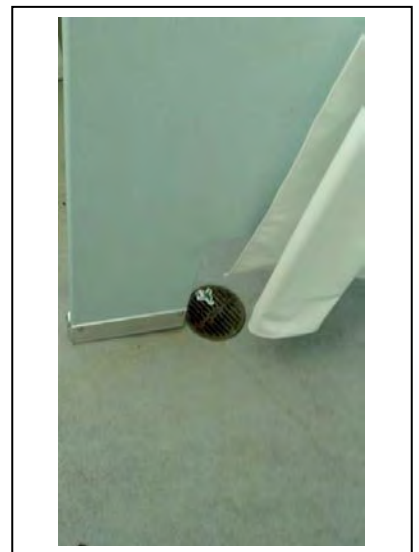
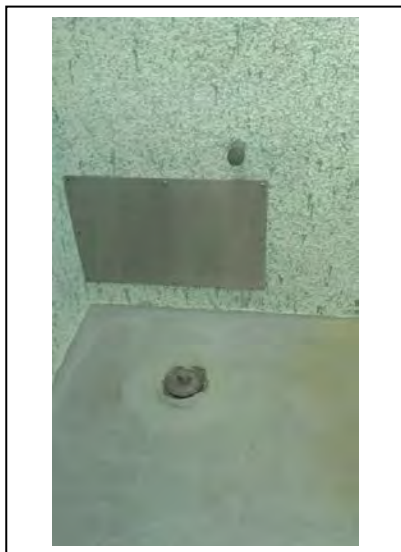
- Men's dry Toilet consists of two (2) floor set tank manual flush valve water closets, four (4) urinals with manual flush valves, two (2) wall hung lavatories with metering faucets, three (3) hose bibbs, one (1) capped water closet and one (1) floor drain.

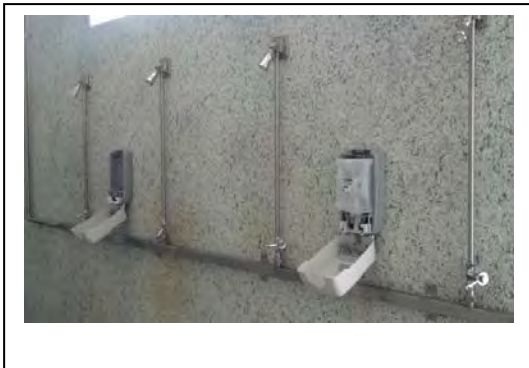
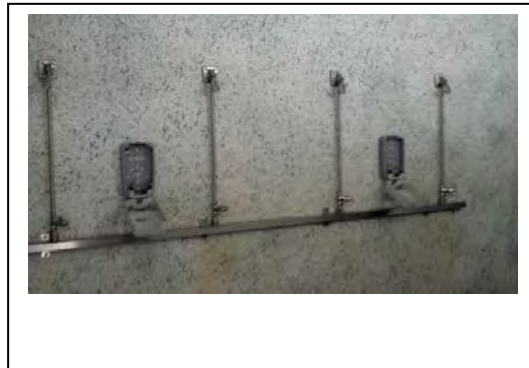
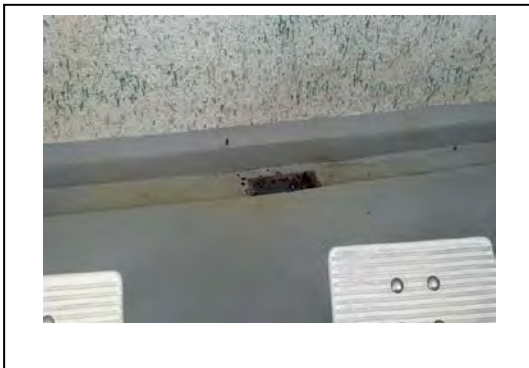
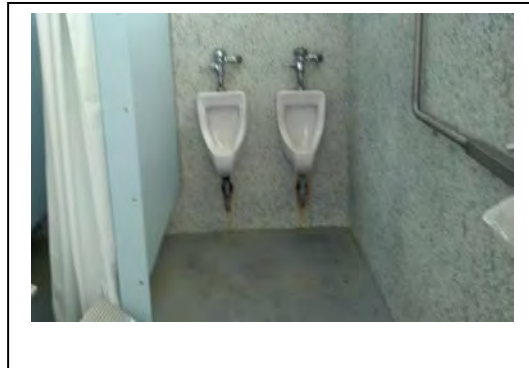
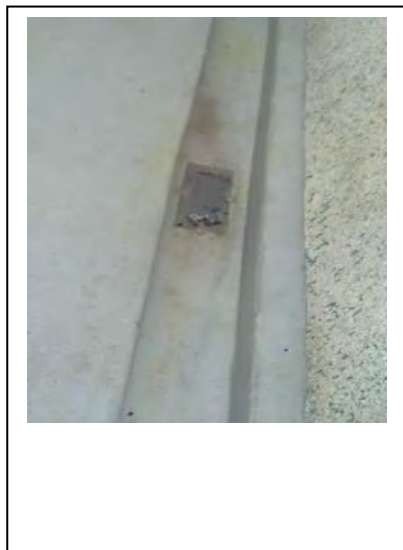
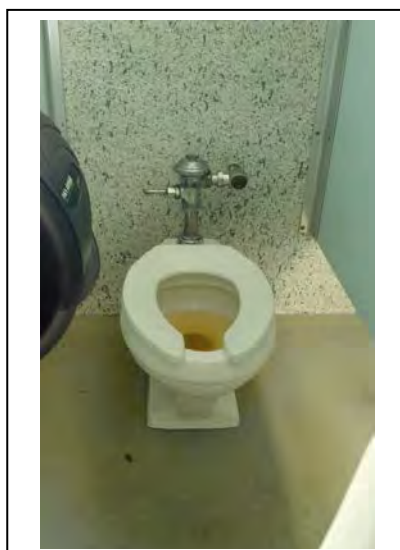
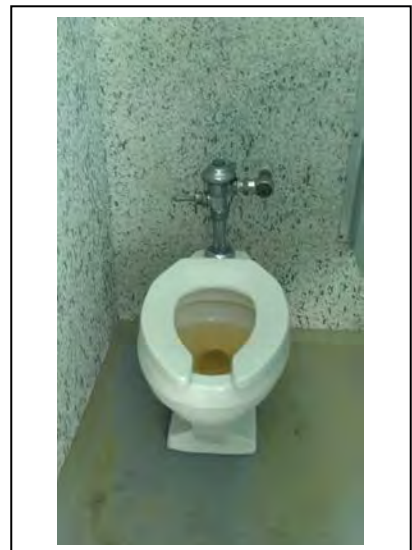
- Men's Wet Toilet consists of eight (8) showers, two (2) trench drains, two (2) floor set manual flush valve water closets and two (2) urinals with manual flush valves.

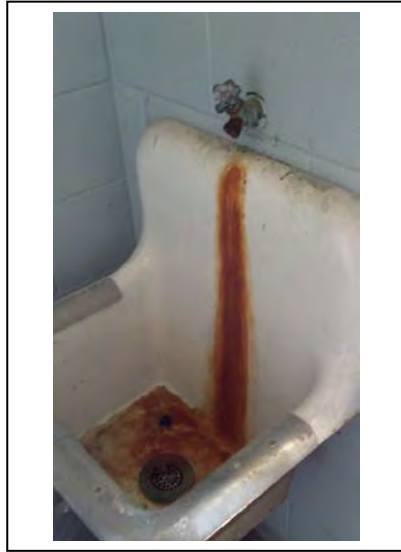
- Janitor Closet consists of one (1) service sink with hose bibb for faucet.

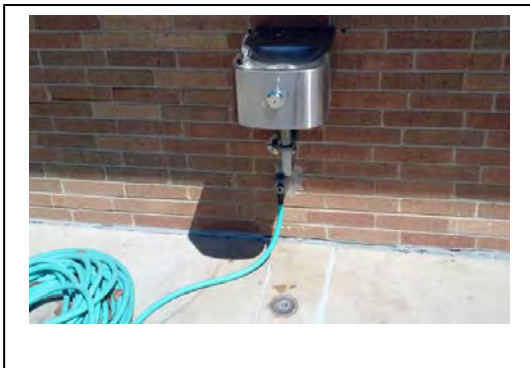
- Building Exterior consists of one (1) drinking fountain and one (1) hose bibb.

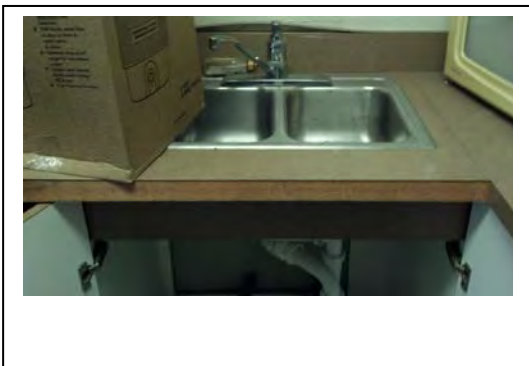
- Concession Area consists of one (1) double bowl stainless steel sink with dual handle faucet.

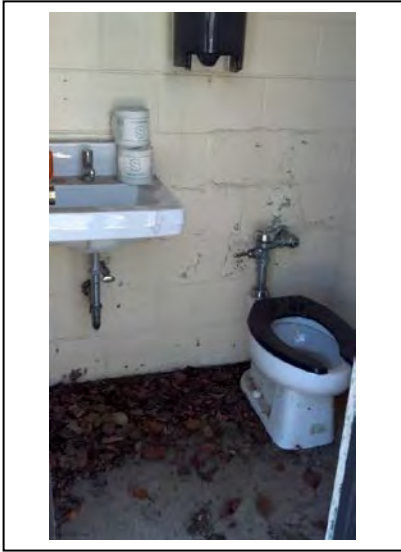
- Exterior Men's Toilet Room consists of one (1) floor set manual flush valve water closet and one (1) wall hung china lavatory with meter faucet.

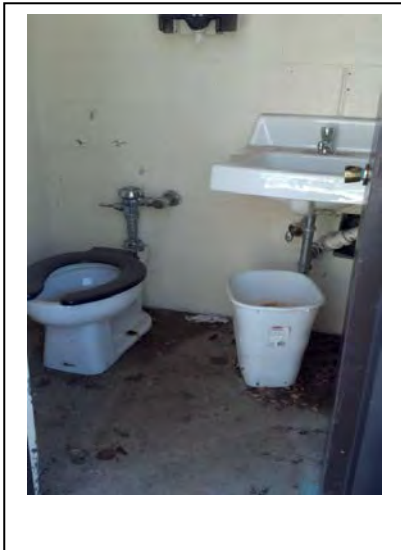
- Exterior Women's Toilet Room consists of one (1) floor set manual flush valve water closet and one (1) wall hung china lavatory with meter faucet.

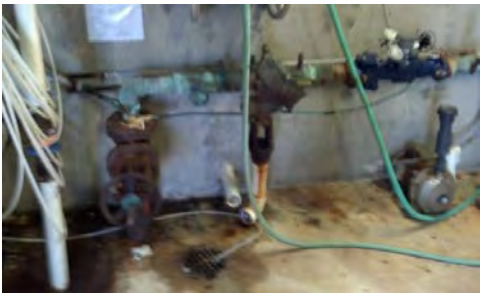
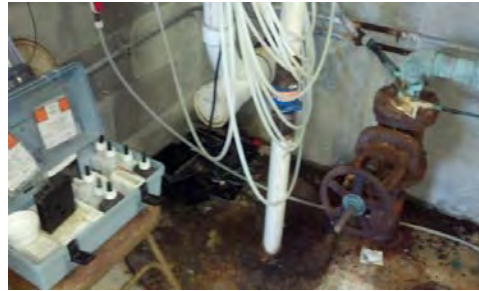
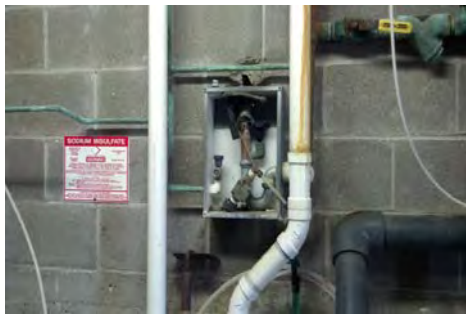
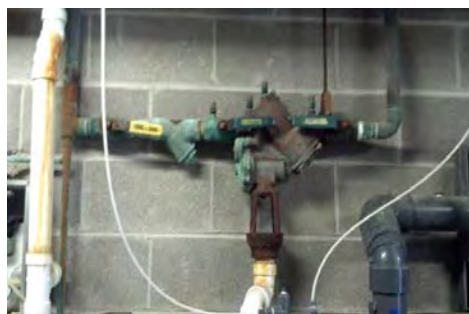
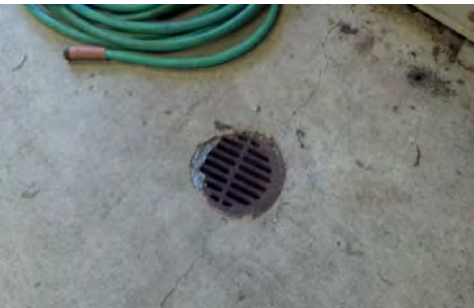
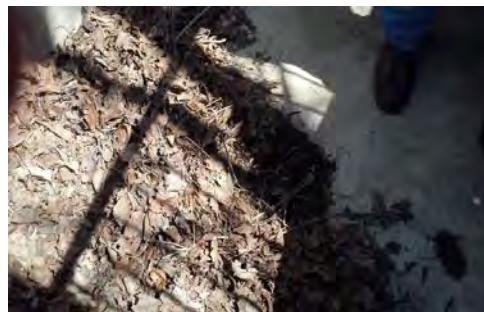
- Building Systems
  - o The building storm drainage system consists of some gutters with downspouts that splash to grade.
  - o The building water distribution system consists of galvanized and stainless steel piping with some copper piping.
  - o The building waste and vent system consists of cast iron and galvanized piping.
- Condition of Fixtures and Equipment
  - o The majority of the existing fixtures are in fair to good condition.
  - o The water heating system appears to be fair to poor condition.
  - o The waste vent and water piping systems appear to be in good condition and working properly.
- Code Violations
  - o No ADA compliant fixtures.
  - o No RPZ one water bathhouse water service.
  - o No expansion tank at water heater.
  - o No vacuum breakers on hose bibs.
  - o No floor drains in exterior toilet rooms
  - o No mixing valve on emergency eye wash.

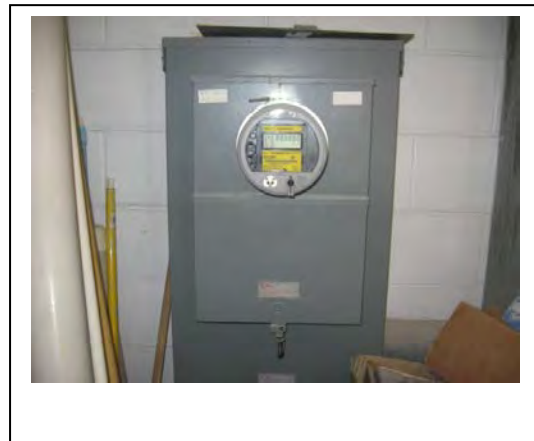
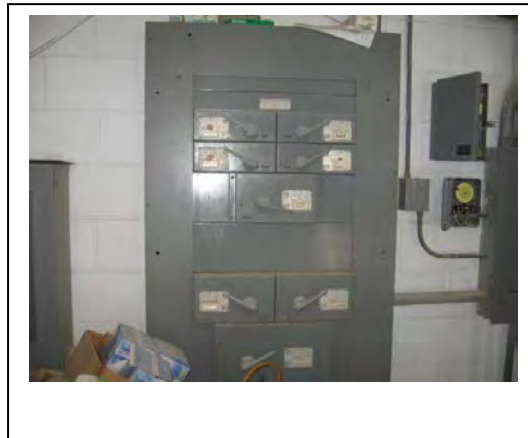
- Bathhouse /Filter Building
  - o The existing electrical service meter and C/T are mounted on the wall next to the main electrical panel located in the filter room. The electrical service is 800 AMPS, 120/208V, 3-phase, 4-Wire.

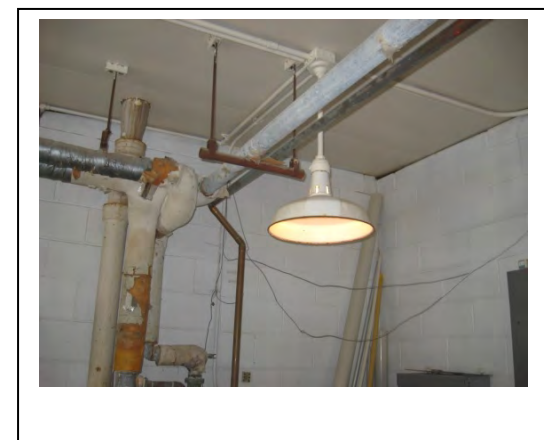
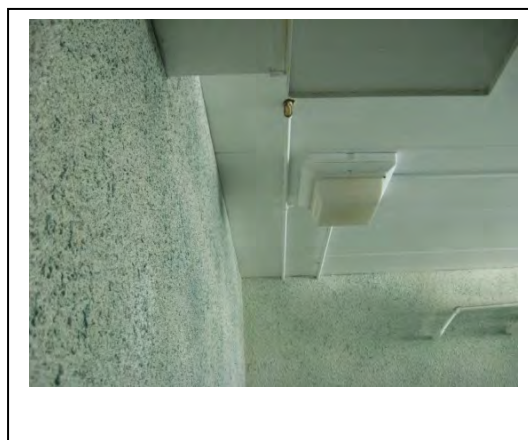
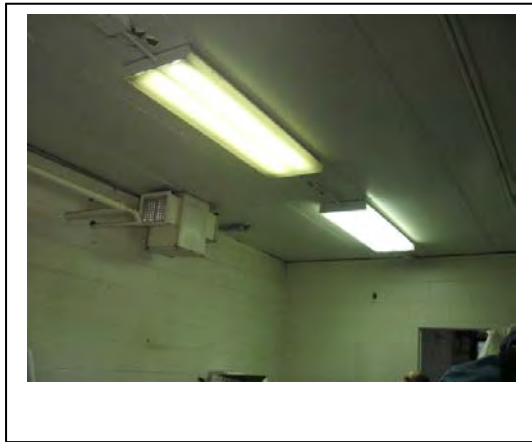
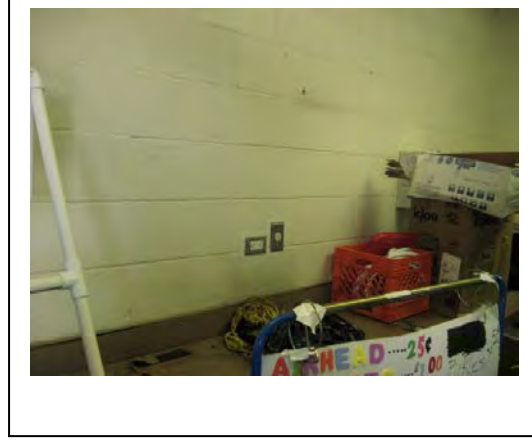
- o The Lap pool power and exterior lighting and the Bathhouse/ Filter Building are connected to this service and panel.
- o Interior lighting consists of 4' wraparound fluorescent ceiling fixtures in the lockers and toilets. The lighting in the filter room consists of pendant mounted porcelain sockets with incandescent lamps.
- o The lighting in the corridors consists of surface mounted fluorescent square fixtures.
- o Receptacles are fed from 20 A circuits.
- o The capacity of the electrical service is adequate.
- o All lighting and receptacles in this building are fed from this panel.
- o All lights are controlled by switches in the interior and 2-pole contactors to control the parking and pool light pole fixtures.
- o Fire alarm system not present.
- o No exit signs or EM battery lights are present.

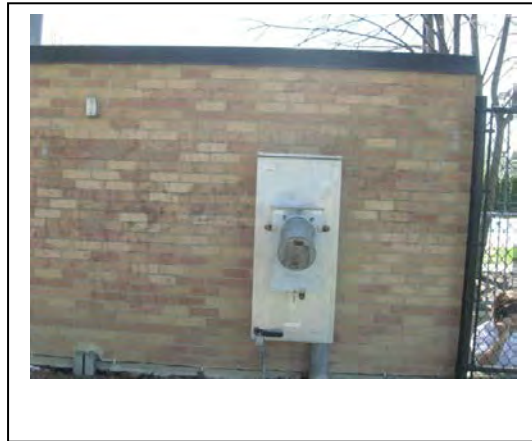
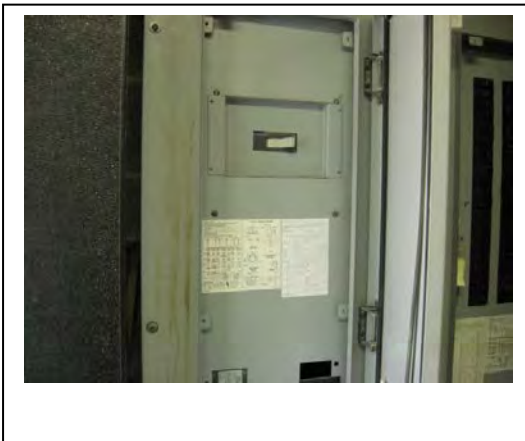
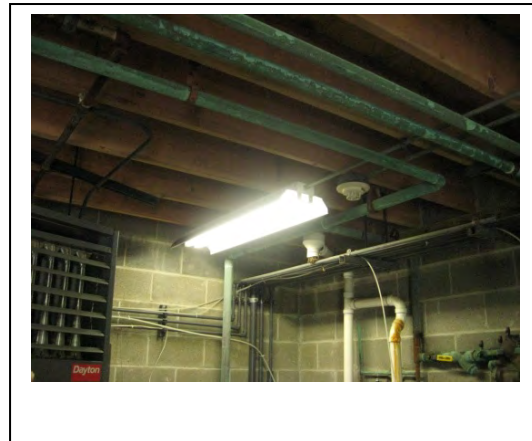
- Spray Pad Filter Building
  - o The existing electrical service meter and C/T are mounted on the exterior wall of the building. The main panel is located within the utility room. The electrical service is 400AMP, 120/208V, 3- phase, 4-W. All equipment, lighting and receptacles are fed from this panel.
  - o Interior Lighting consists of (2) 4' industrial strip light fixtures, pendant mounted.
  - o Exit signs are present.
  - o No EM Battery lights present.
  - o Fire alarm system is present but not addressable.
  - o Interior light fixtures are controlled by wall switches.
  - o A 2-pole contactor controls the pool light pole fixtures.
