## FACILITY EVALUATION

Date: 24 September 2013

PROJECT NAME: Facility Evaluation  
Lufkin & Jefferson Pools

WA PROJECT NUMBER: 2013-010

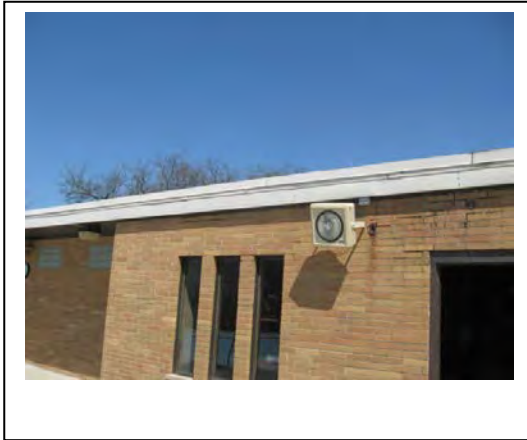
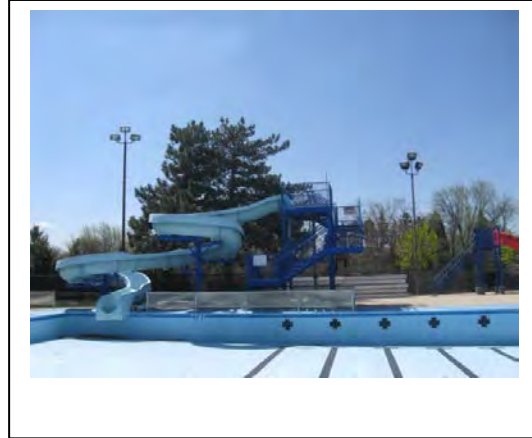
- o Based on visual observation:
- o The exterior lighting in the Bathhouse/Filter Building consists of:
- o Wall mounted incandescent fixtures on the exterior wall.
- o HID surface mounted box fixtures in the front canopy.
- o HID Flood Light fixtures mounted on a 30' poles in the parking lot.

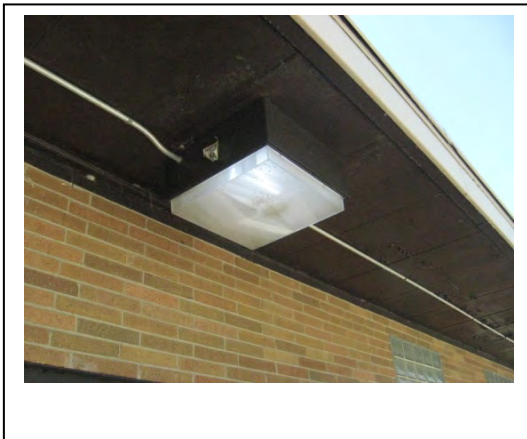
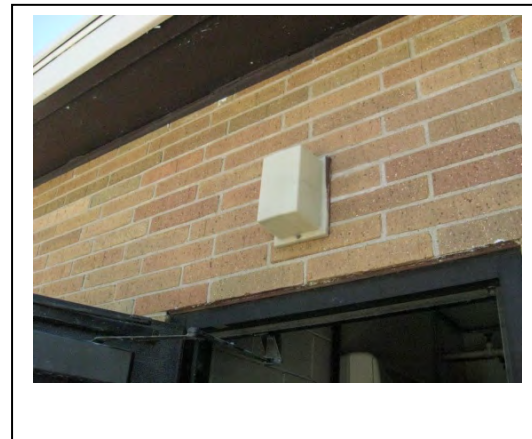
- o The exterior lighting in the Spray Pad Filter Building consists of:
- o Wall mounted incandescent fixture on the exterior wall.
- o HID shoe box fixtures mounted on a 20' poles in the parking lot

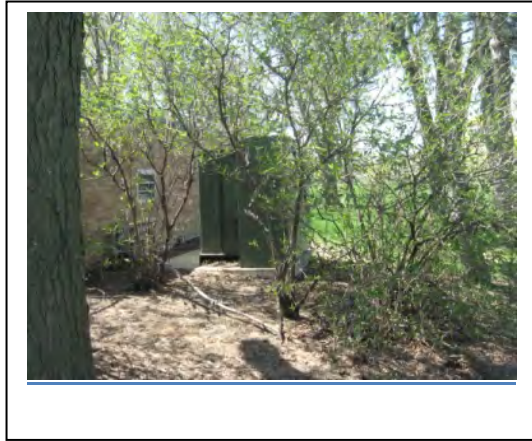
- o There is a pad mounted transformer located behind the Spray Pad Filter Building feeding both building services.
