FEBRUARY 2008

FINAL REPORT

# SANITARY SEWER MASTER PLAN

**VILLAGE OF VILLA PARK**

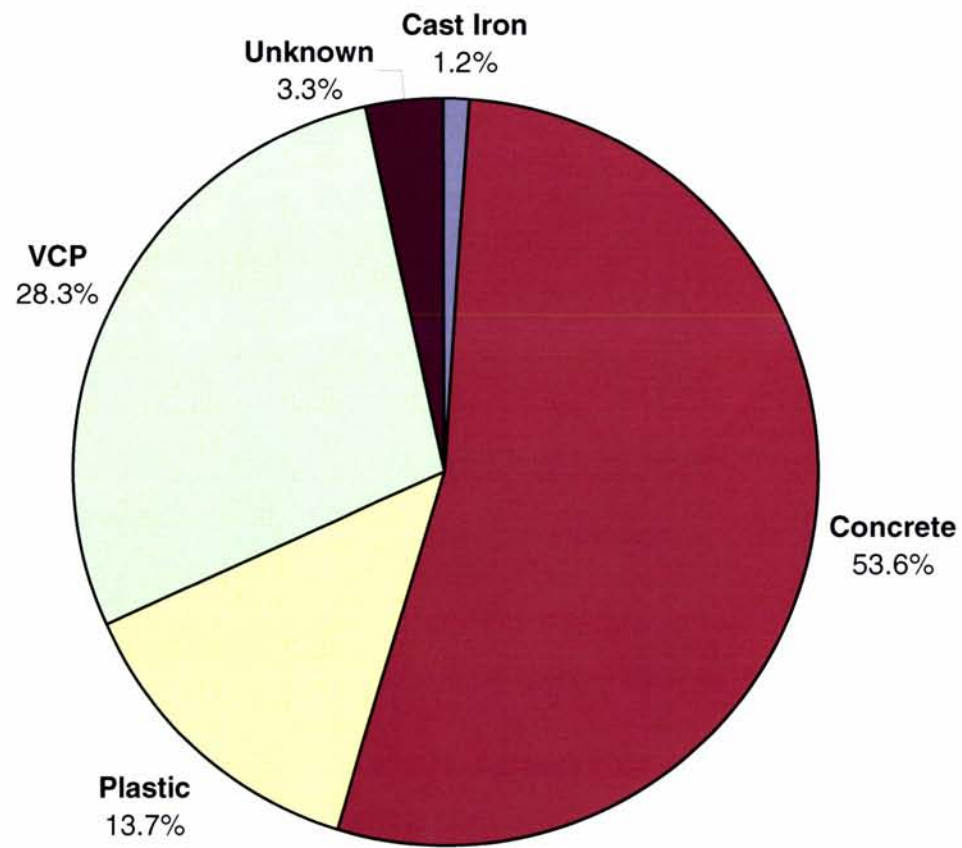
**Figure 2C**  
**Village of Villa Park**  
**Percentage of Sanitary Sewer by Material**

<b>Material</b>	<b>Length (Feet)</b>	<b>Length (Miles)</b>	<b>% Total</b>
Cast Iron	2,566	0.49	1.2%
Concrete	116,443	22.05	53.6%
Plastic	29,716	5.63	13.7%
VCP	61,449	11.64	28.3%
Unknown	7,207	1.36	3.3%

Expansion since the 1960's has been mainly of vitrified clay pipe (concrete for larger sizes) and latterly of PVC. The distribution of pipe by material is presented in Table 2C and Figure 2C and graphically on Exhibit 2-3.

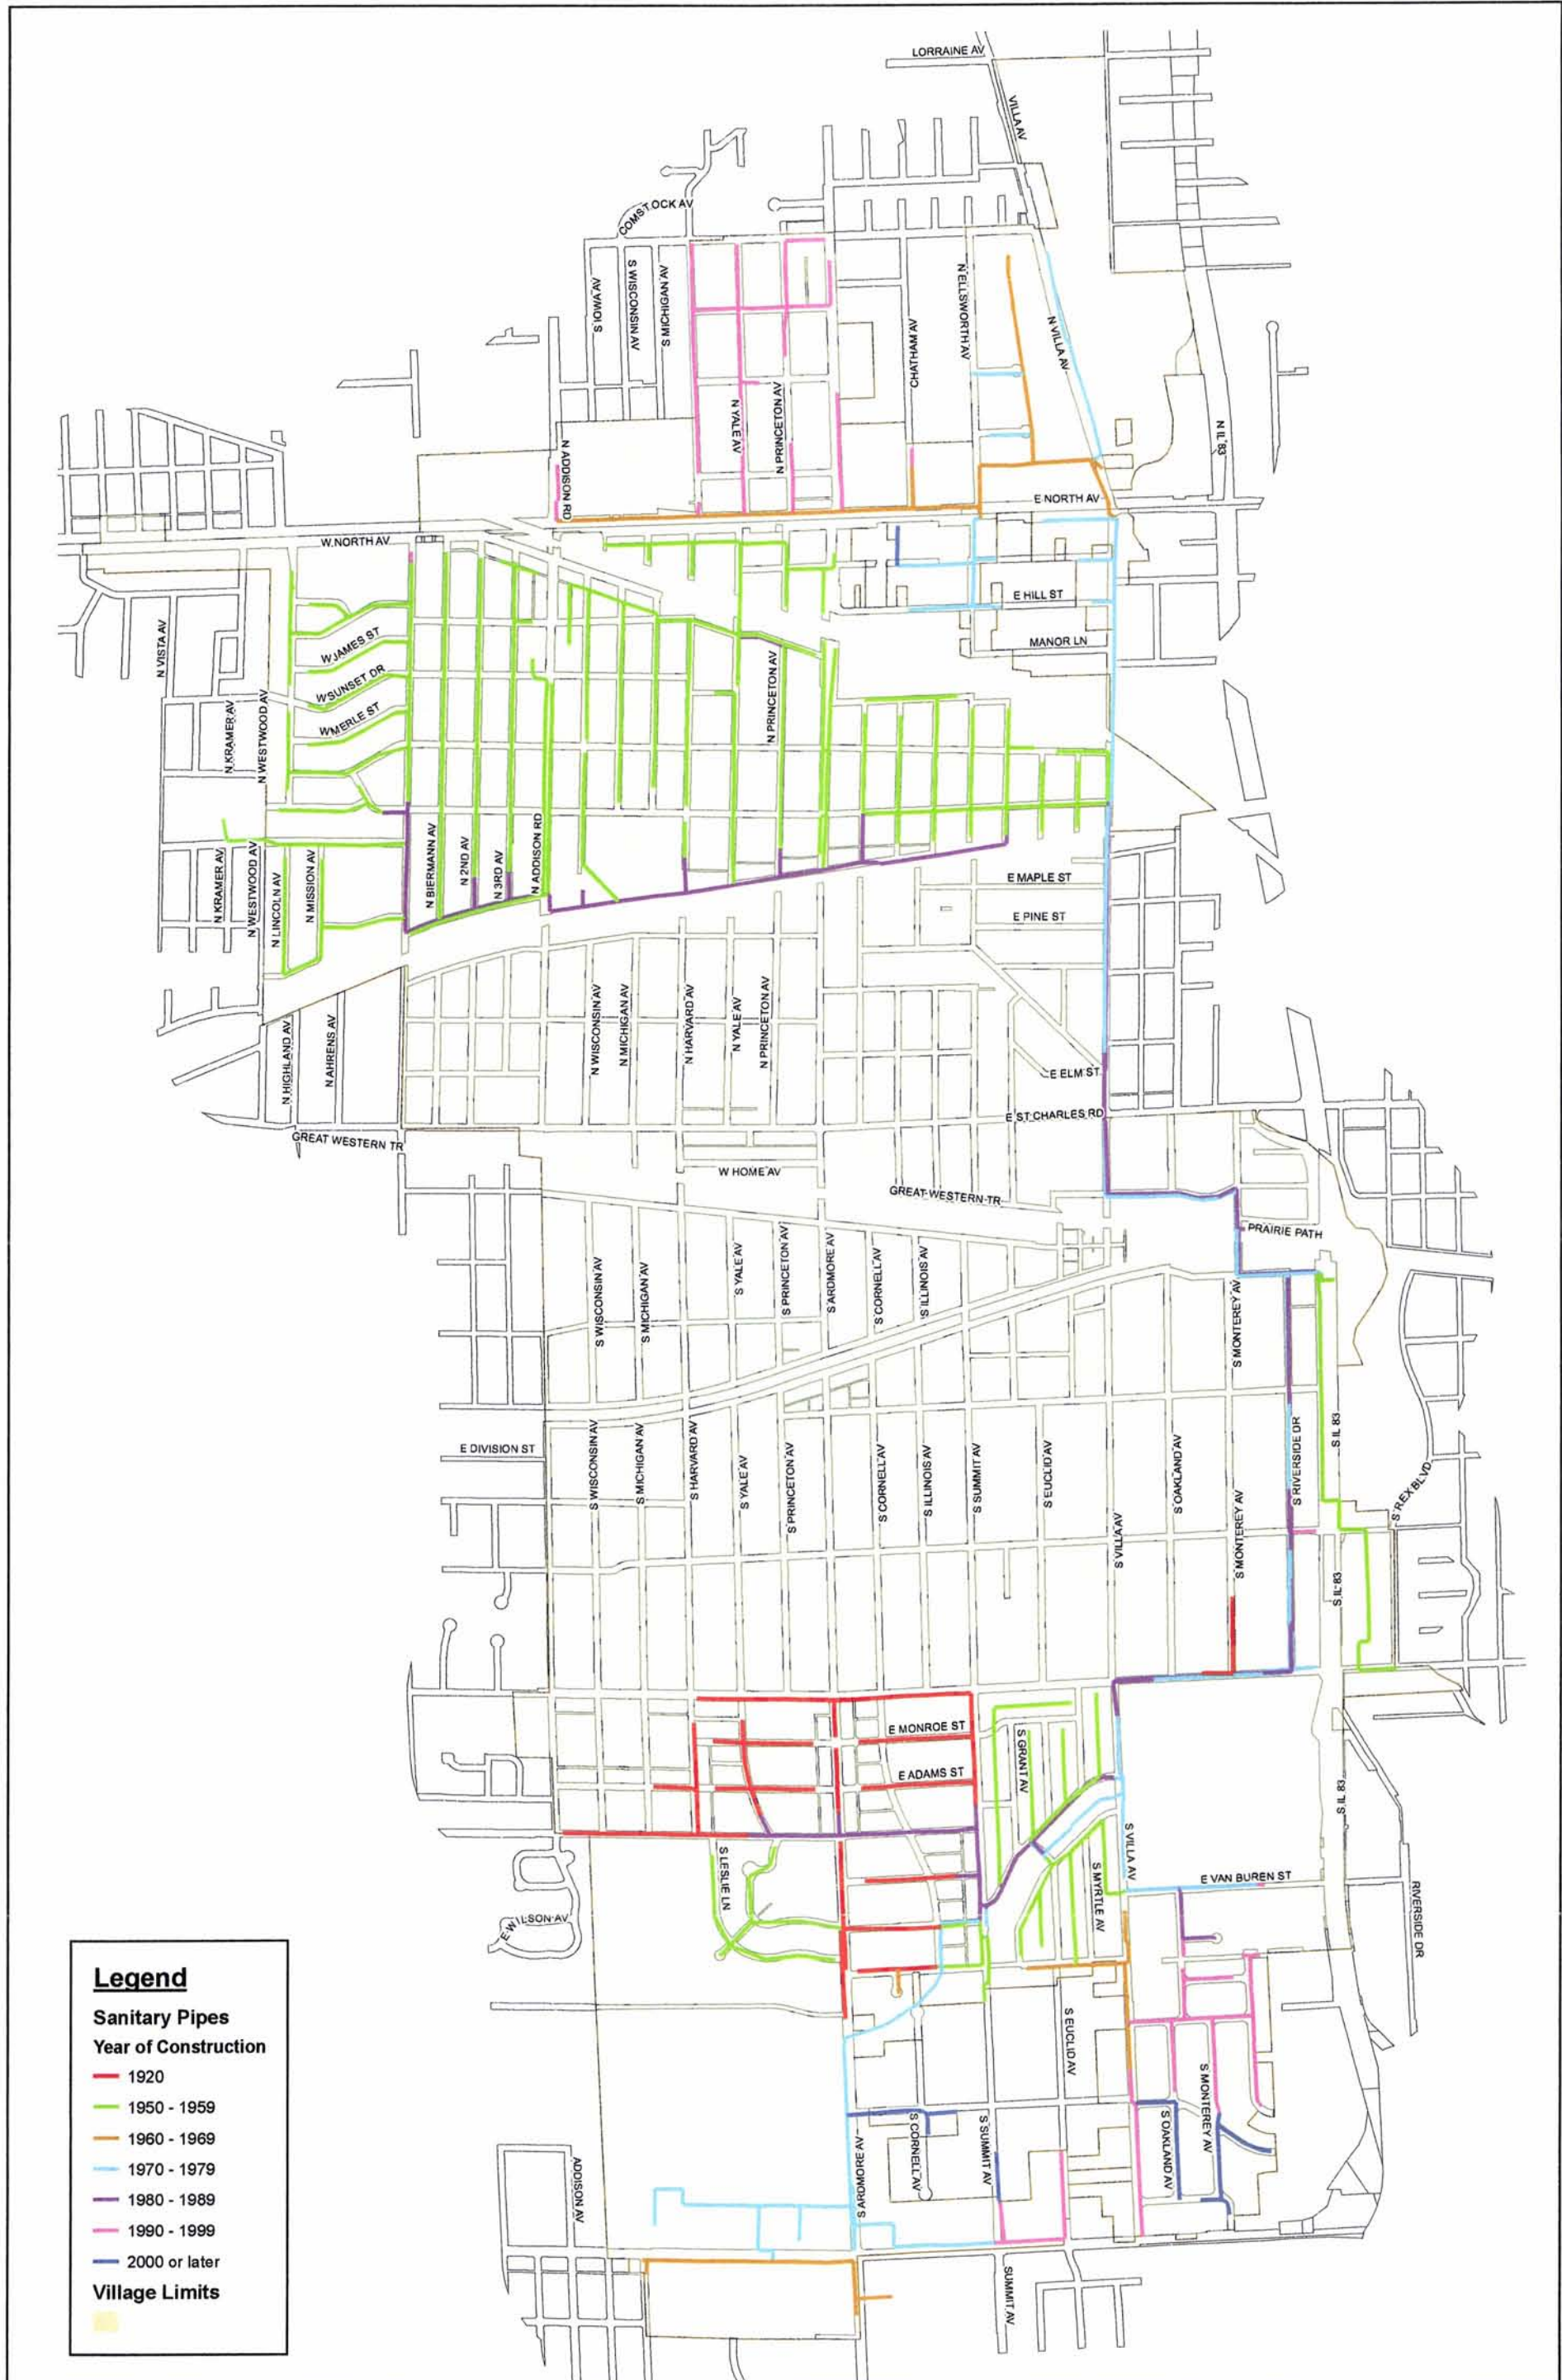
**Sanitary Pipes**  
**Year of Construction**

- 1920
- 1950 - 1959
- 1960 - 1969
- 1970 - 1979
- 1980 - 1989
- 1990 - 1999
- 2000 or later

The Village began developing in the 1920's with expansion every decade, with the exception of the 1940's. Table 2B and Figure 2B represent the distribution of sanitary sewers by age, and the graphical representation is shown in Exhibit 2-2. The main growth period for the Village was during the 1950's when 90,000 ft of sanitary sewer was constructed. The sewers built during this time period were predominantly unreinforced concrete pipe and serve the area on the north side of the Village between the UP and the CCP railroads, including those areas known as the ABC Streets and College Streets.
